Tropicana Joint Venture

Tropicana Gold Mine (TGM)
Ministerial Statement No 839
Annual Compliance Assessment Report
24 September 2017 to 23 September 2018

20 December 2018

Tropicana Gold Project, Annual Compliance Assessment Report

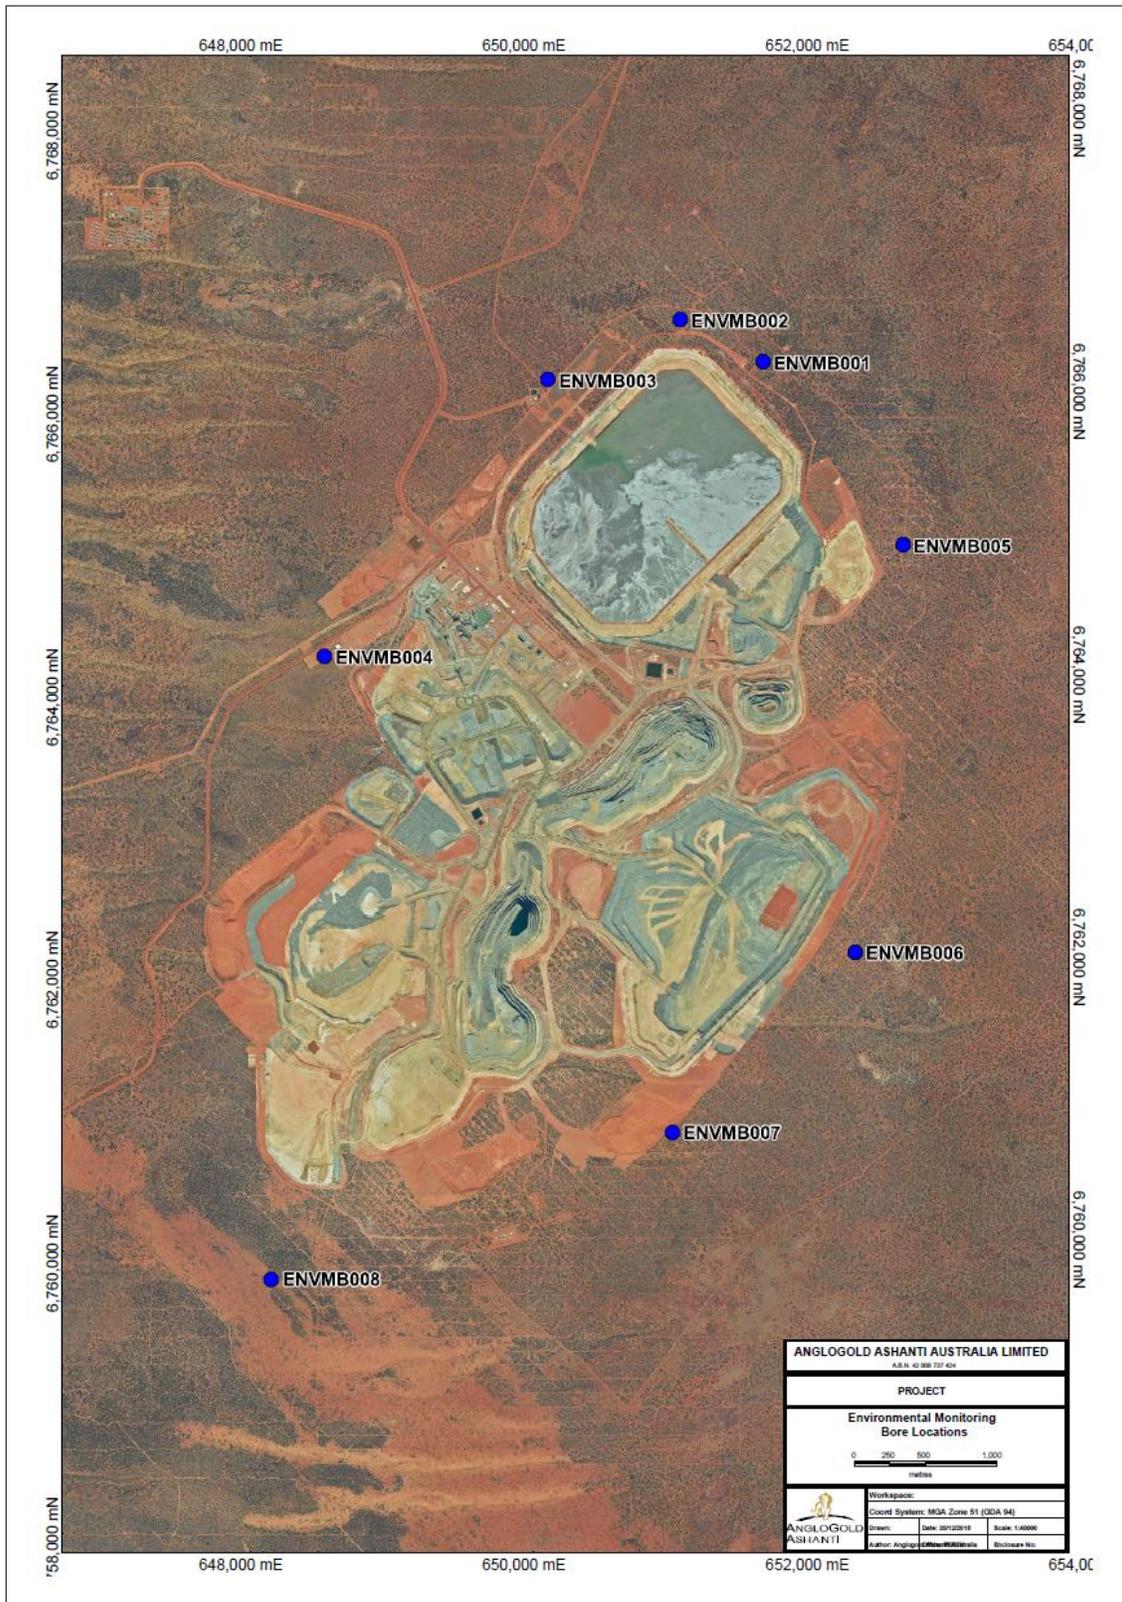
Figure 4: Ministerial Groundwater Monitoring Bore Locations

Groundwater monitoring from the sixteen (8 deep and 8 shallow) monitoring bores installed around the TSF and waste landform footprints (Figure 4) was undertaken throughout 2018. A summary of results from the sampling events are provided in Appendix 3. Results obtained from these monitoring bores were compared with trigger values which were established in 2014. Analysis of results indicates that changes in groundwater quality (baseline groundwater quality +/- 10%) has occurred at some monitoring bores.

ENVMB001, located to the north of the TSF, has displayed results for multiple parameters that are above baseline water quality triggers values, including Calcium (Ca), Chloride (Cl), Cobalt (Co), Magnesium (Mg), Nitrate (NO₃), Sodium (Na), WAD Cyanide (Cn), Electrical Conductivity (EC) as well as Total Dissolved Solids (TDS). Groundwater quality changes at ENVMB001 are influenced by the operation of the nearby TSF.

To mitigate potential impacts to environmental values, AGAA implemented a Seepage Mitigation Project in 2016. The Seepage Mitigation Project was continued throughout the reporting period, including ongoing operation of ten (10) seepage recovery bores. During the current reporting period the following improvements have been made to the project:

- Drilling of five (5) additional groundwater recovery bores on the southern and northern side of the TSF;
- Installation of four (4) additional groundwater recovery bores (TSFRB18 and TSFRB 19) to the South as well as two (TSFRB17 and TSFRB23) to the North of the TSF;
- Installation of eleven (11) additional monitoring bores surrounding the TSF.

AGAA will continue to monitor groundwater across the TGM and will implement additional mitigation actions as and when required to minimise the environmental impacts of the operation. The next review of the Environmental Monitoring Strategy will re-evaluate the 10% variation against baseline groundwater quality trigger, particularly in the context of a saline to hypersaline groundwater environment.

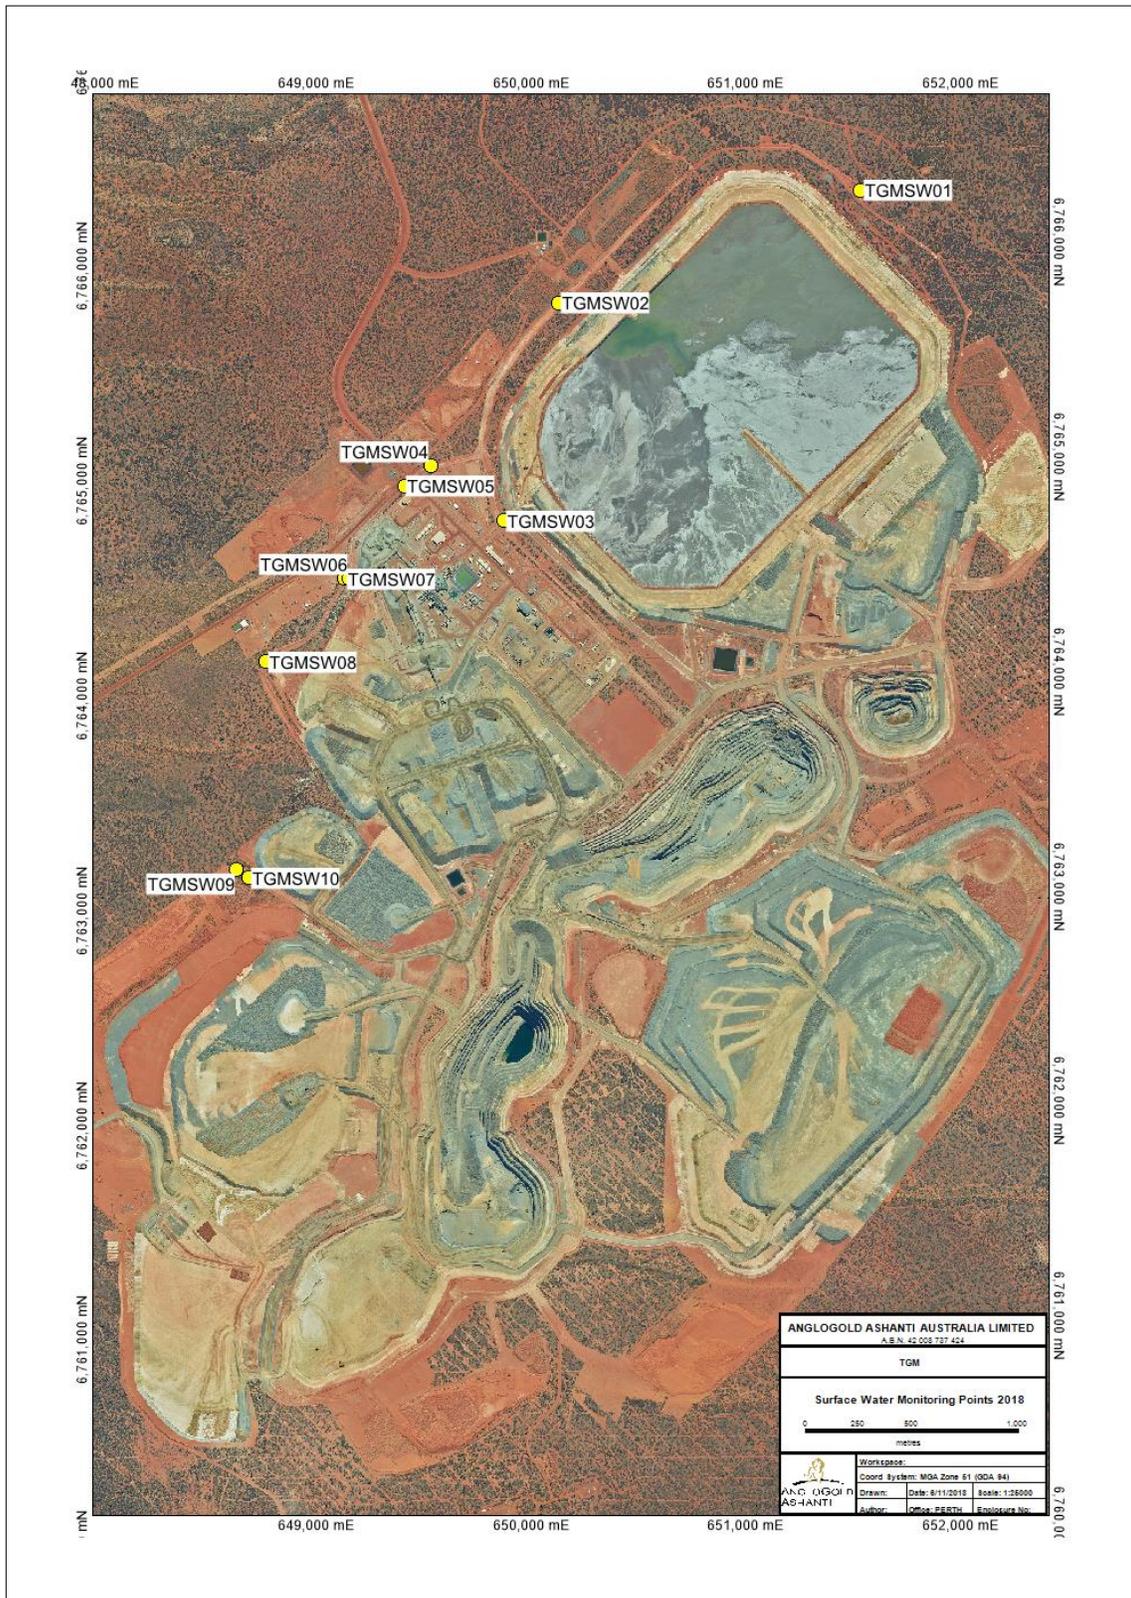
Figure 5: Surface Water Monitoring Locations

Stormwater (previously referred to as surface water) monitoring sites have been established around the TSF and waste landforms (Figure 5) as required by Condition 8.2. Due to the absence of continuous standing surface water, samples from these locations have only been obtained following rainfall events where there is stormwater runoff (>20 mm rainfall in 24 hours). Results from stormwater sampling locations are provided in Appendix 4.

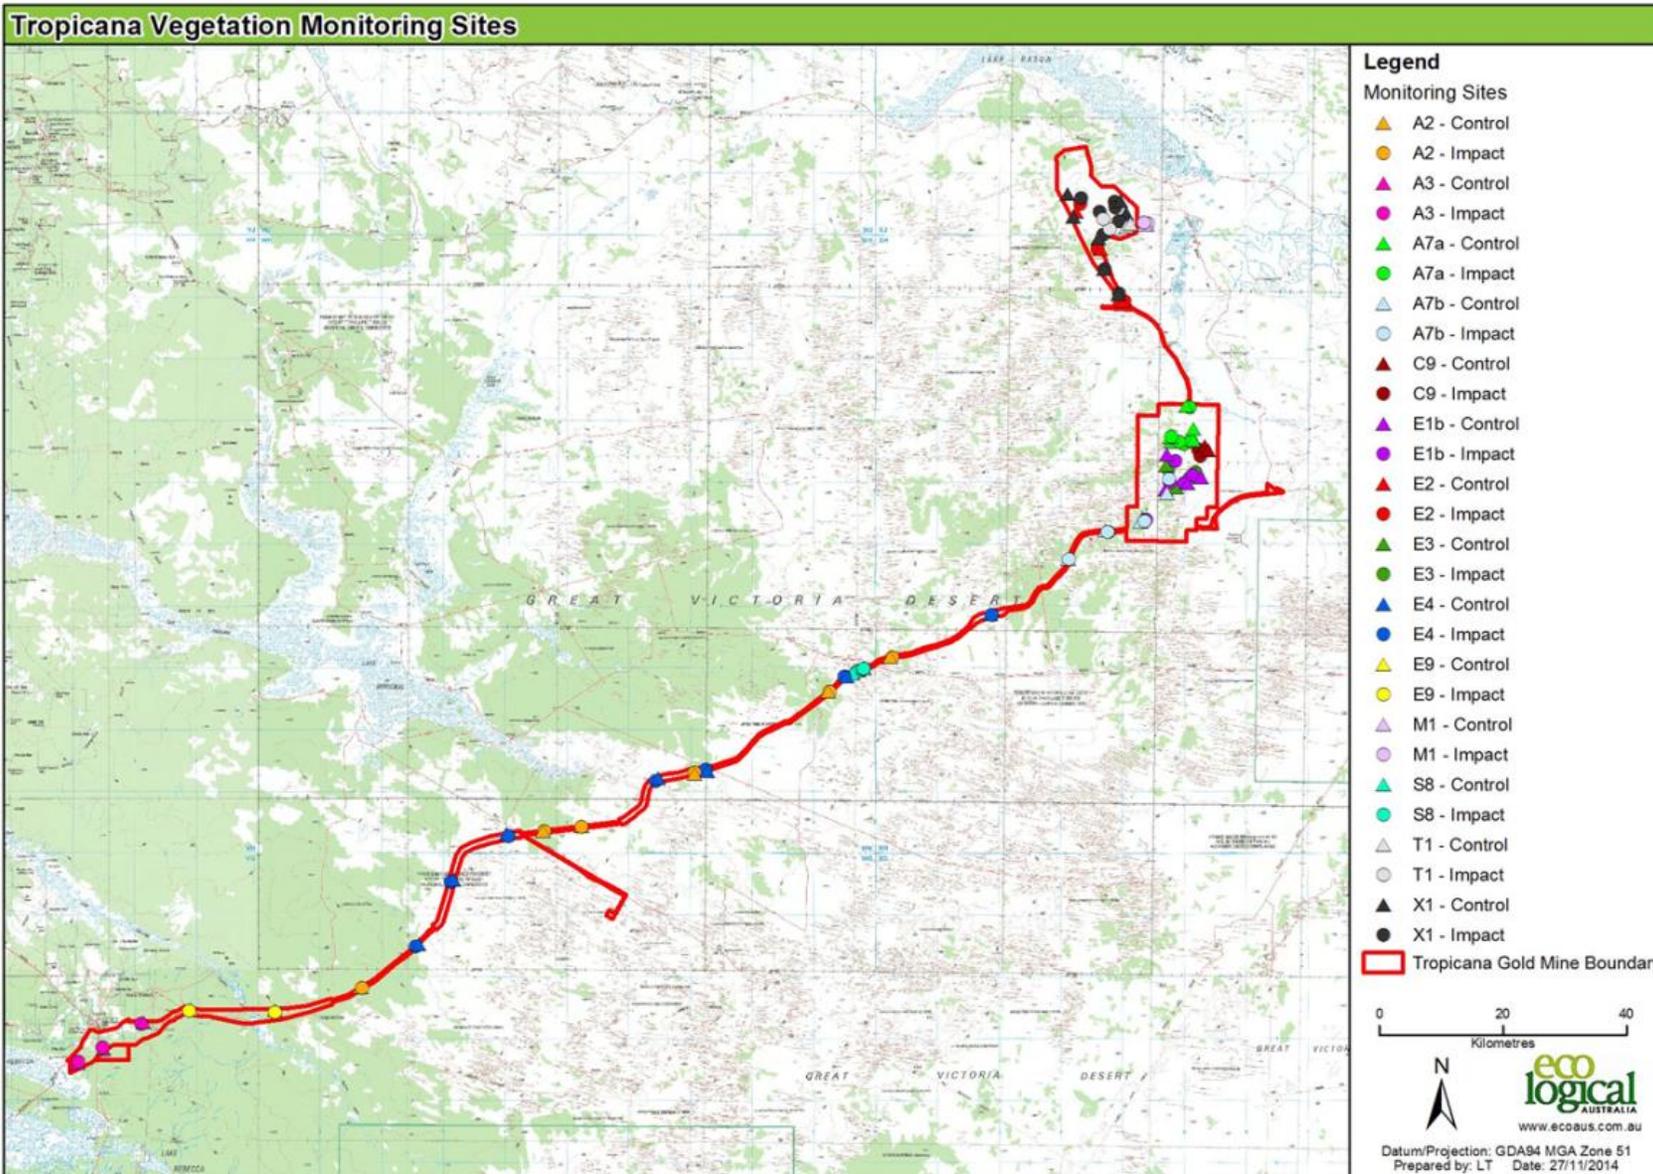
Figure 6: Vegetation condition monitoring quadrat locations (2015)

The 2017 monitoring program was undertaken by Eco Logical Australia Pty Ltd in October 2017 (Appendix 9). The monitoring program involved assessment of high resolution digital multi-spectral imagery and field survey verification at 112 quadrats (20m by 20m in size). The locations of the vegetation monitoring sites are shown in Figure 6.

The remote sensing analysis did not detect any changes in vegetation that were directly or indirectly attributable as an impact from the Project. Furthermore, no significant change was detected within any of the field monitoring sites. The results of the remote sensing analysis were consistent with field survey results and confirm the process as a sensitive and robust tool for quantitatively measuring change.
