**TROPICANA JOINT VENTURE**

**Tropicana Gold Project Ministerial Statement No. 839 – 2016/2017 Annual Compliance Assessment Report**

Tropicana Gold Mine (TGM)  
 Ministerial Statement No 839  
 Annual Compliance Assessment Report  
 24 September 2016 to 23 September 2017

Document Reference: CAR20171221

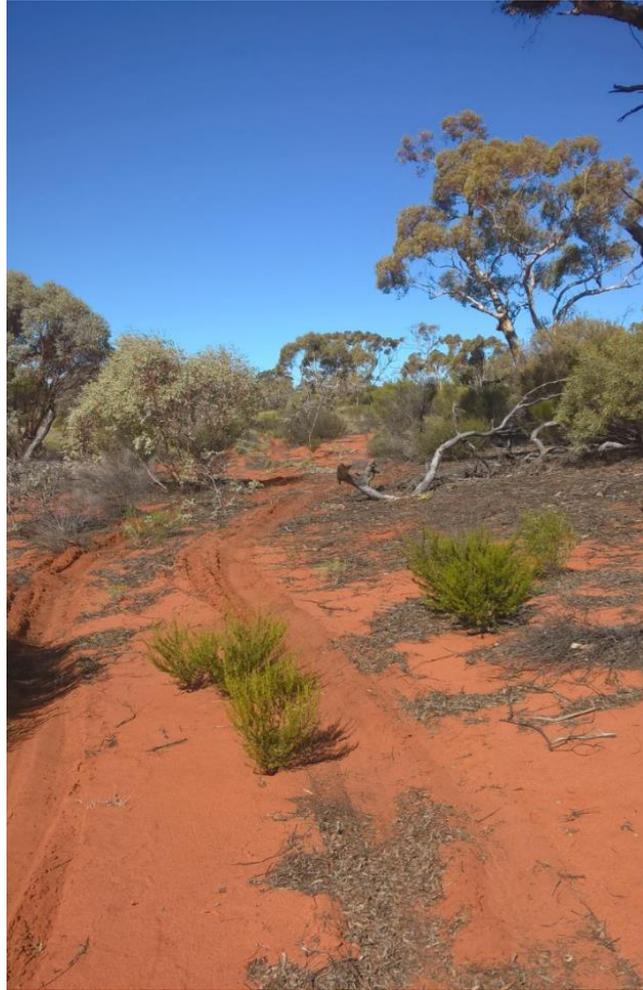
*Figure 1: Sandy slopes*

- The northern drill lines are through thick Mulga Woodland.
- All rubbish and hydrocarbon spills to be removed upon completion of drilling.
- Upon completion of drilling, the AC drill holes are to be rehabilitated to level AC1 in accordance with the Exploration Rehabilitation Procedure.
  - The hole is plugged at a minimum of 40 cm below surface using an 80 mm diameter drill plug filled with soil.
  - The hole is backfilled and mounded above the plug with low permeability material (e.g. clay or oxide drill cuttings) to promote water shedding away from the drill hole.
  - Any available topsoil / growth medium is spread over the mounded drill hole.

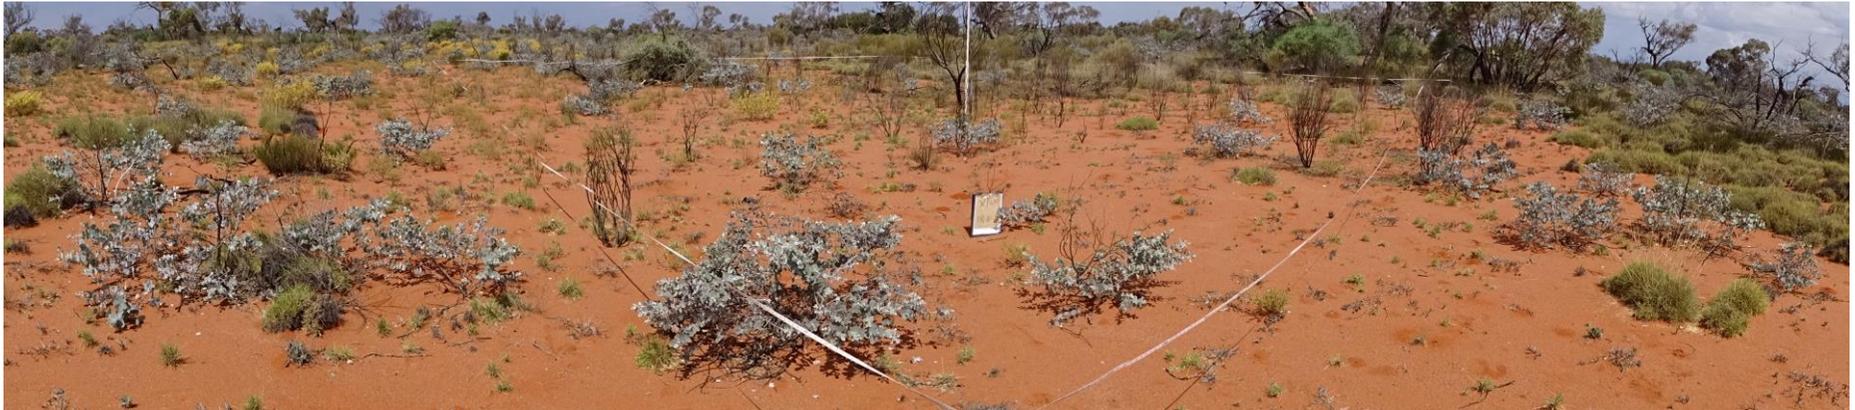
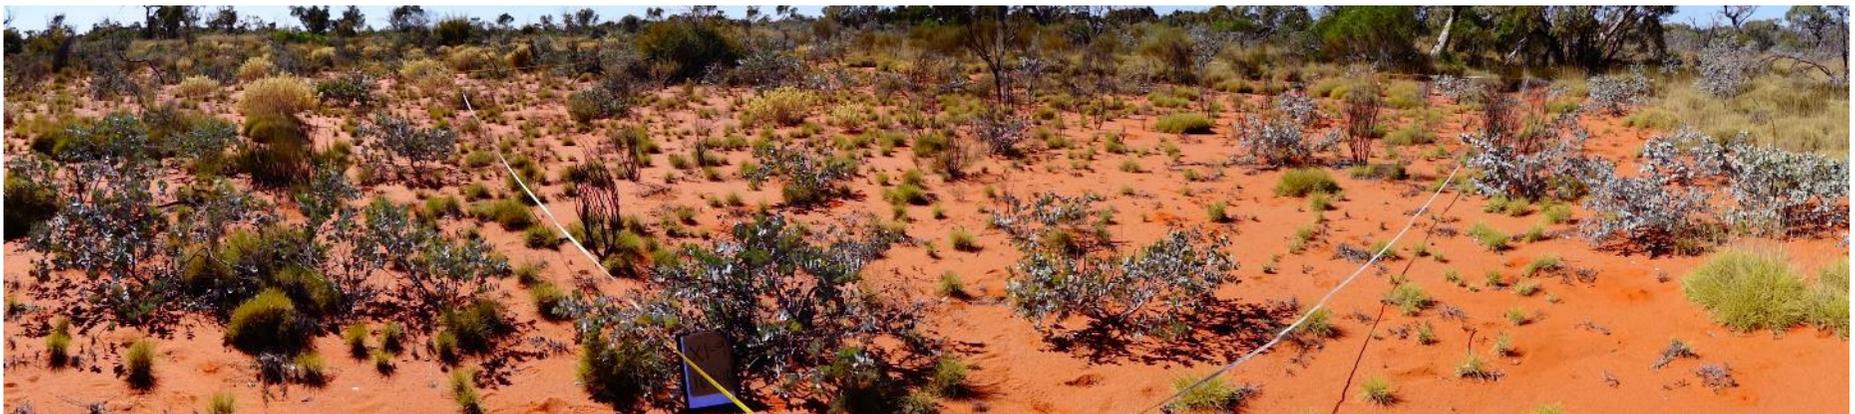
Figure 9: An example of healthy post-fire recruitment at impact site X1-9 burnt in 2012

A comparison between the 2016 survey and the baseline data identified four impact sites (E2-5, X1-1, X1-7 and X1-9) with a decrease in overall foliar cover by more than 25%. Of these, when the impact sites were compared to the paired reference sites, one impact site (X1-9) had a negative difference of -57% relative to the paired reference site. This difference was also seen in the 2015 survey and is the result of a lightning initiated fire which went through the area in 2012. This site is continuing to regenerate post-fire (**Figure 9**). The remaining sites, did not show a decreasing trend relative to their reference site. As these results are not due to mining related activities, they do not need further investigations under Trigger 1.
