Tropicana Gold Project Ministerial Statement No. 839 – 2018/2019 Annual Compliance Assessment Report

Tropicana Gold Mine (TGM)
Ministerial Statement No 839
Annual Compliance Assessment Report
24 September 2018 to 23 September 2019

Tropicana Gold Project, Annual Compliance Assessment Report

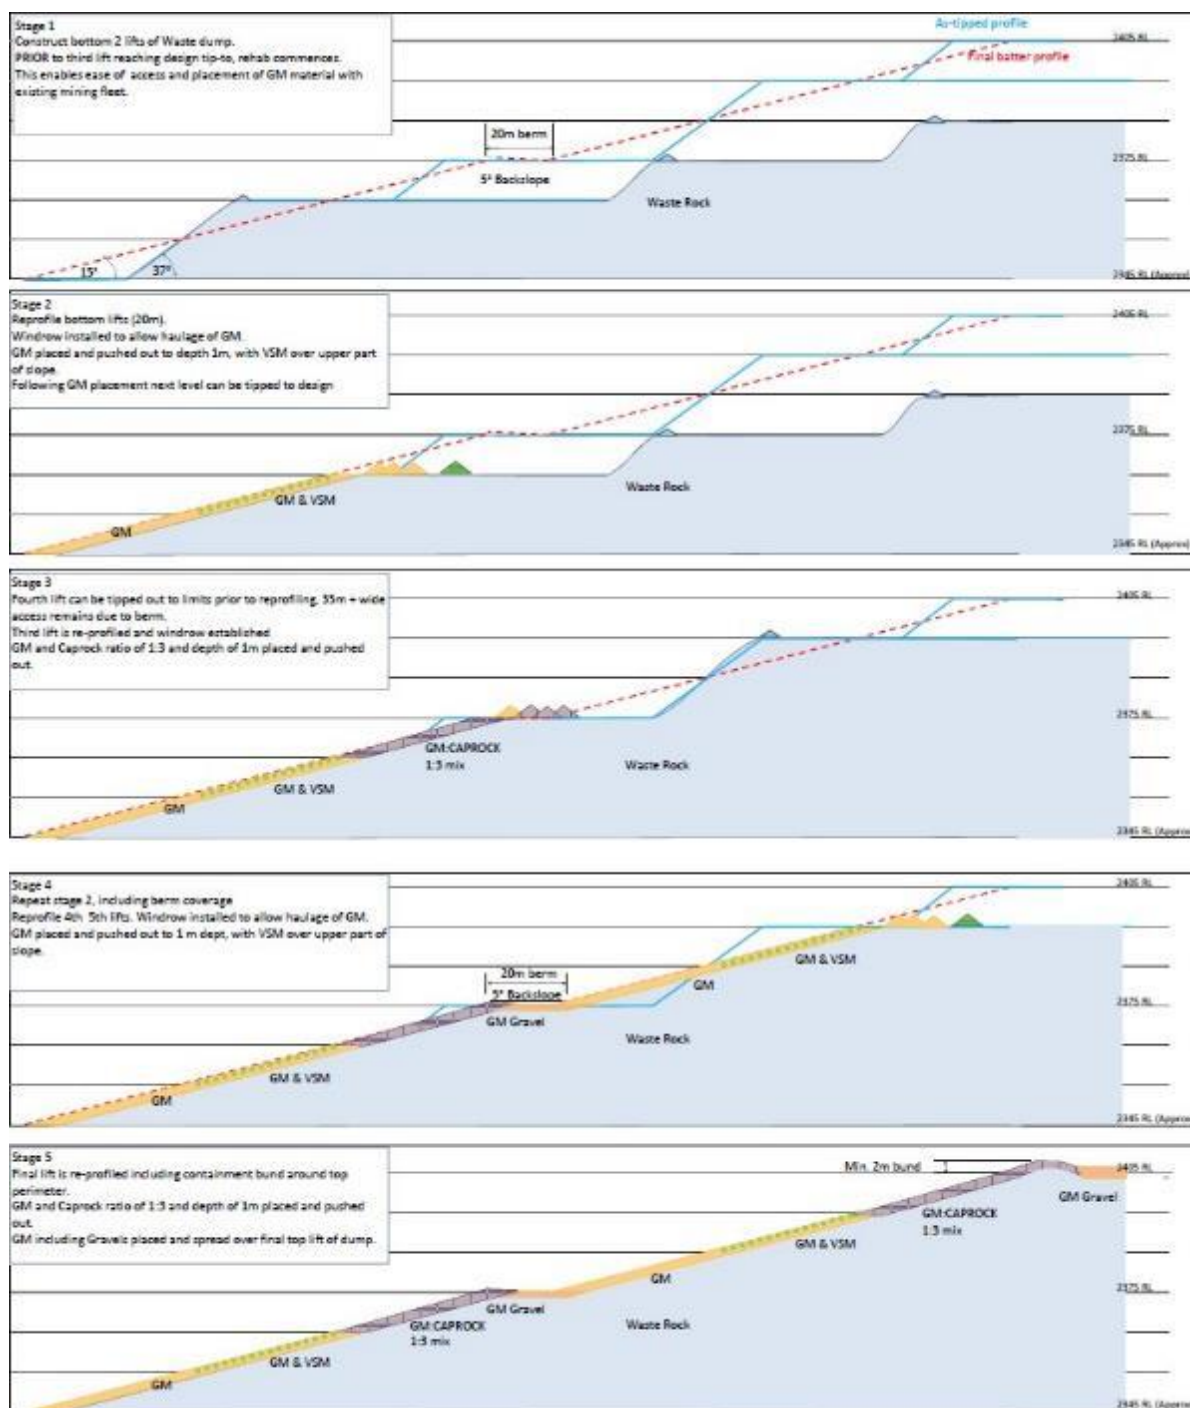
Figure 1: Evolution of waste landform rehabilitation from construction to completion.

The upper section batters comprising the 1:3 mixture of GMS:Caprock will be contour ripped to assist in the erosion control through promoting infiltration and reducing the velocity of any runoff which may occur. The upper surface of the waste landform will also be ripped to reduce compaction, promote infiltration and trap resources (i.e. water, seed, organic matter) to promote revegetation.
