Tropicana Gold Project Ministerial Statement No. 839 – 2022/2023 Annual Compliance Assessment Report.

Tropicana Gold Mine (TGM)
Ministerial Statement No 839
Annual Compliance Assessment Report
24 September 2022 to 23 September 2023

Document Reference: CAR20231220

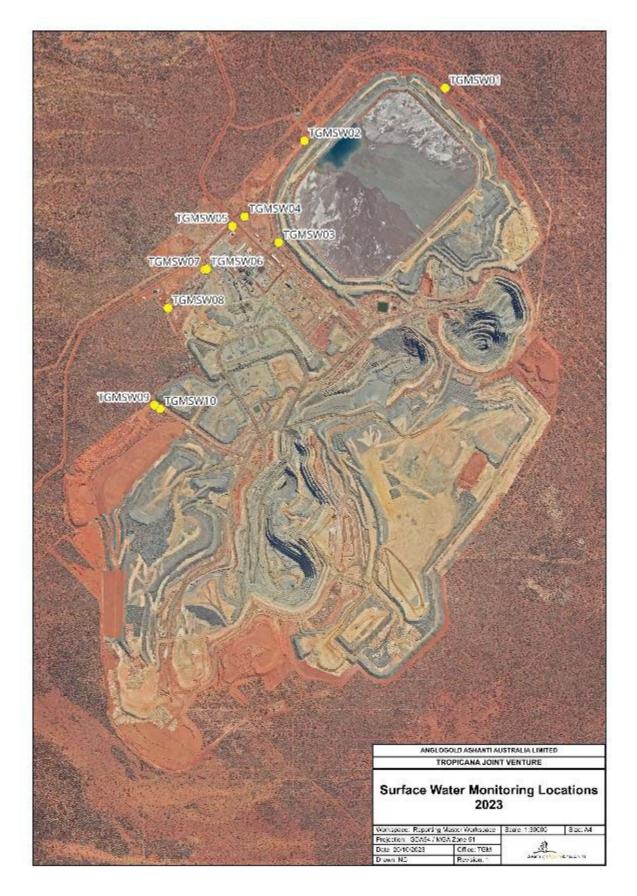
**Figure 5: Storm Water Monitoring Locations**

Stormwater (previously referred to as surface water) monitoring sites have been established around the TSF and waste landforms (Figure 5) as required by Condition 8.2. Due to the absence of continuous standing surface water, samples from these locations are only obtained following rainfall events where there is stormwater runoff (>20 mm rainfall in 24 hours). No such rainfall events have occurred during the reporting period, further information such as the stormwater sampling locations is provided in Appendix D.

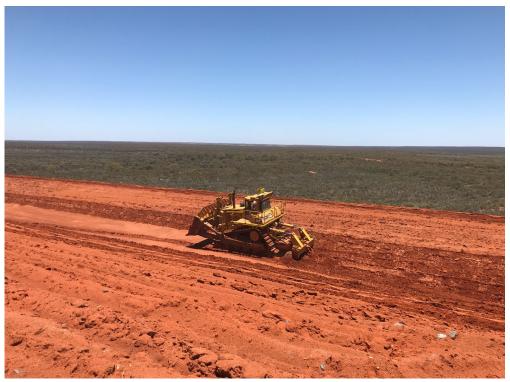
Figure 1: Waste landform batter slope progressive rehabilitation.

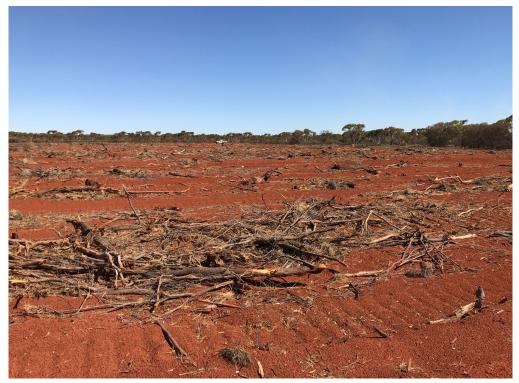
During the reporting period, rehabilitation earthworks were completed on a hardstand / laydown area located to the south of the TGM Aerodrome. Rehabilitation earthworks over the approximately 5 ha area were completed in November 2022 and involved the respreading of topsoil and stockpiled vegetation mulch and scarification of the disturbed footprint.

Figure 2: Hardstand / laydown progressive rehabilitation.

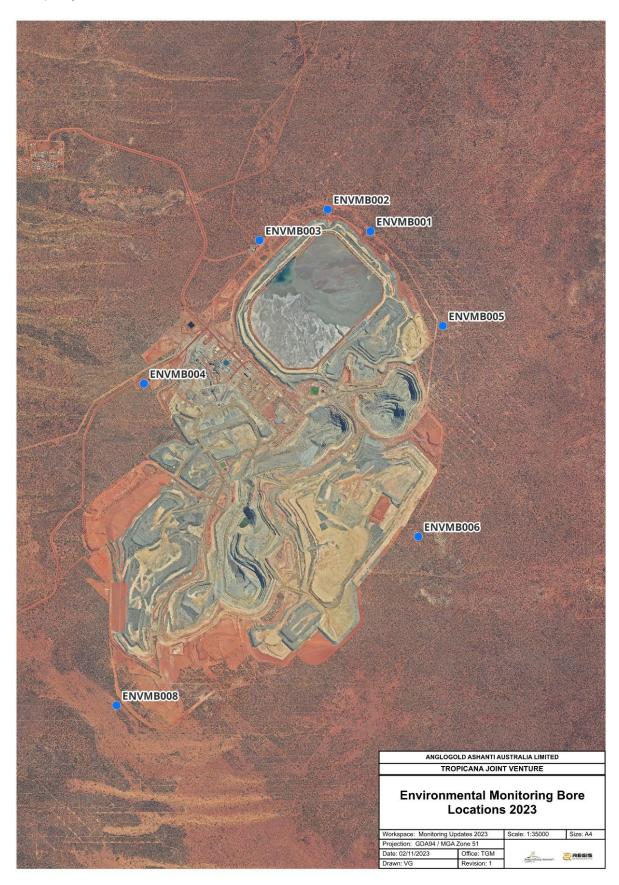
Figure 1 Environmental Monitoring Bores Locations 2023

Groundwater monitoring of the ENV series monitoring bores has been undertaken since prior to TSF construction and used to establish baseline groundwater conditions with subsequent annual reporting to DWER under MS839. Locations of the ENV series bores are shown in Figure 1.

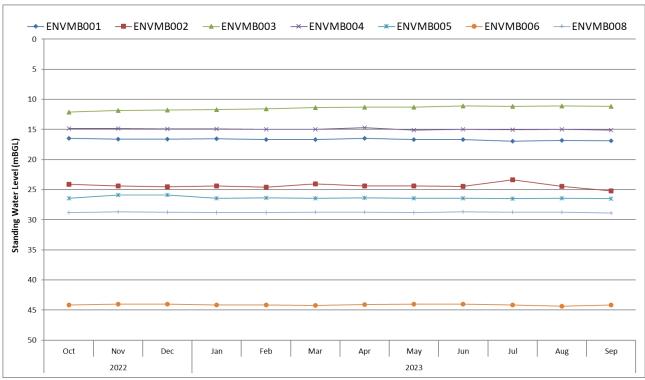
Monthly groundwater levels for each bore during the reporting period are presented in Figure 2 and Table 1 (attached):

- ENVMB003 (west of the TSF) reported a 1.13 m rise in groundwater level over the reporting period, which has been attributed to the TSF recovery bores to the west of the TSF being decommissioned for the TSF waste landform extension.
- Monitoring bores ENVMB004-008 reported water level fluctuations of less than 0.3 m over the reporting period.

Figure 2 Groundwater Levels in Environmental Monitoring Bores October 2022 – September 2023

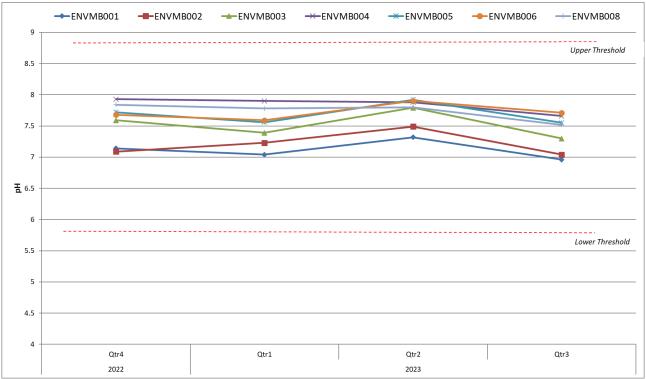
Laboratory pH results (Figure 3) in all bores remained within the trigger level thresholds for the reporting period and remain consistent with previously reported results.

Figure 3 Laboratory pH in Environmental Monitoring Bores Q4 2022 to Q3 2023

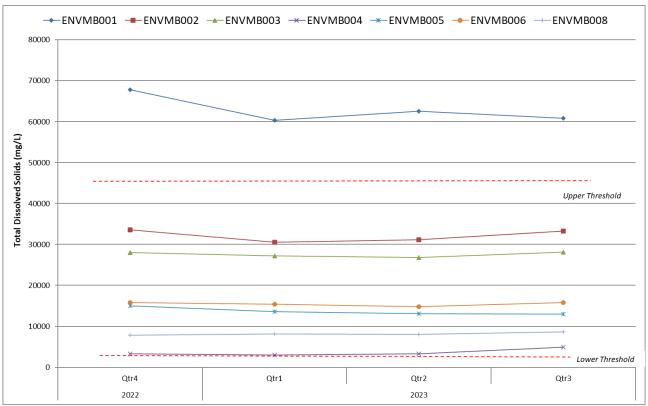
Figure 4 Total Dissolved Solids in Environmental Monitoring Bores Q4 2022 – Q3 2023

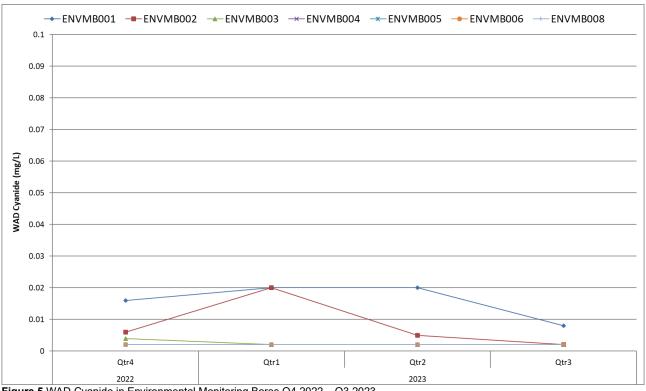
Figure 5 WAD Cyanide in Environmental Monitoring Bores Q4 2022 – Q3 2023

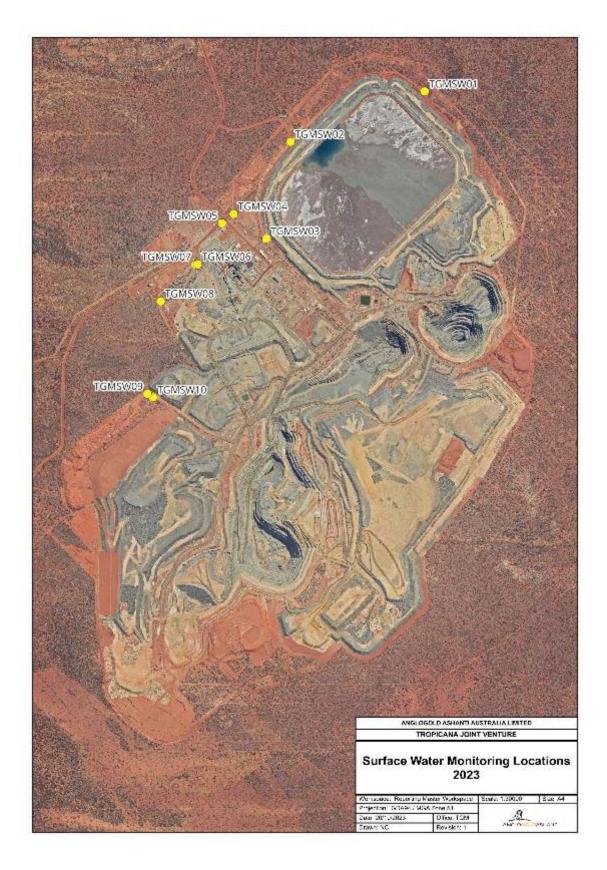
Figure 1 Stormwater Sampling Locations

Stormwater (previously referred to as Surface Water) quality monitoring is undertaken in accordance with the Tropicana Gold Mine Environmental Monitoring Strategy, with samples collected following significant rainfall events of over 20 millimetres (mm) in 24 hours, or when stormwater is observed in collection locations.
