Tropicana Gold Project Ministerial Statement No. 839 – 2021/2022 Annual Compliance Assessment Report.

Tropicana Gold Mine (TGM)
Ministerial Statement No 839
Annual Compliance Assessment Report
24 September 2021 to 23 September 2022

Document Reference: CAR20221219

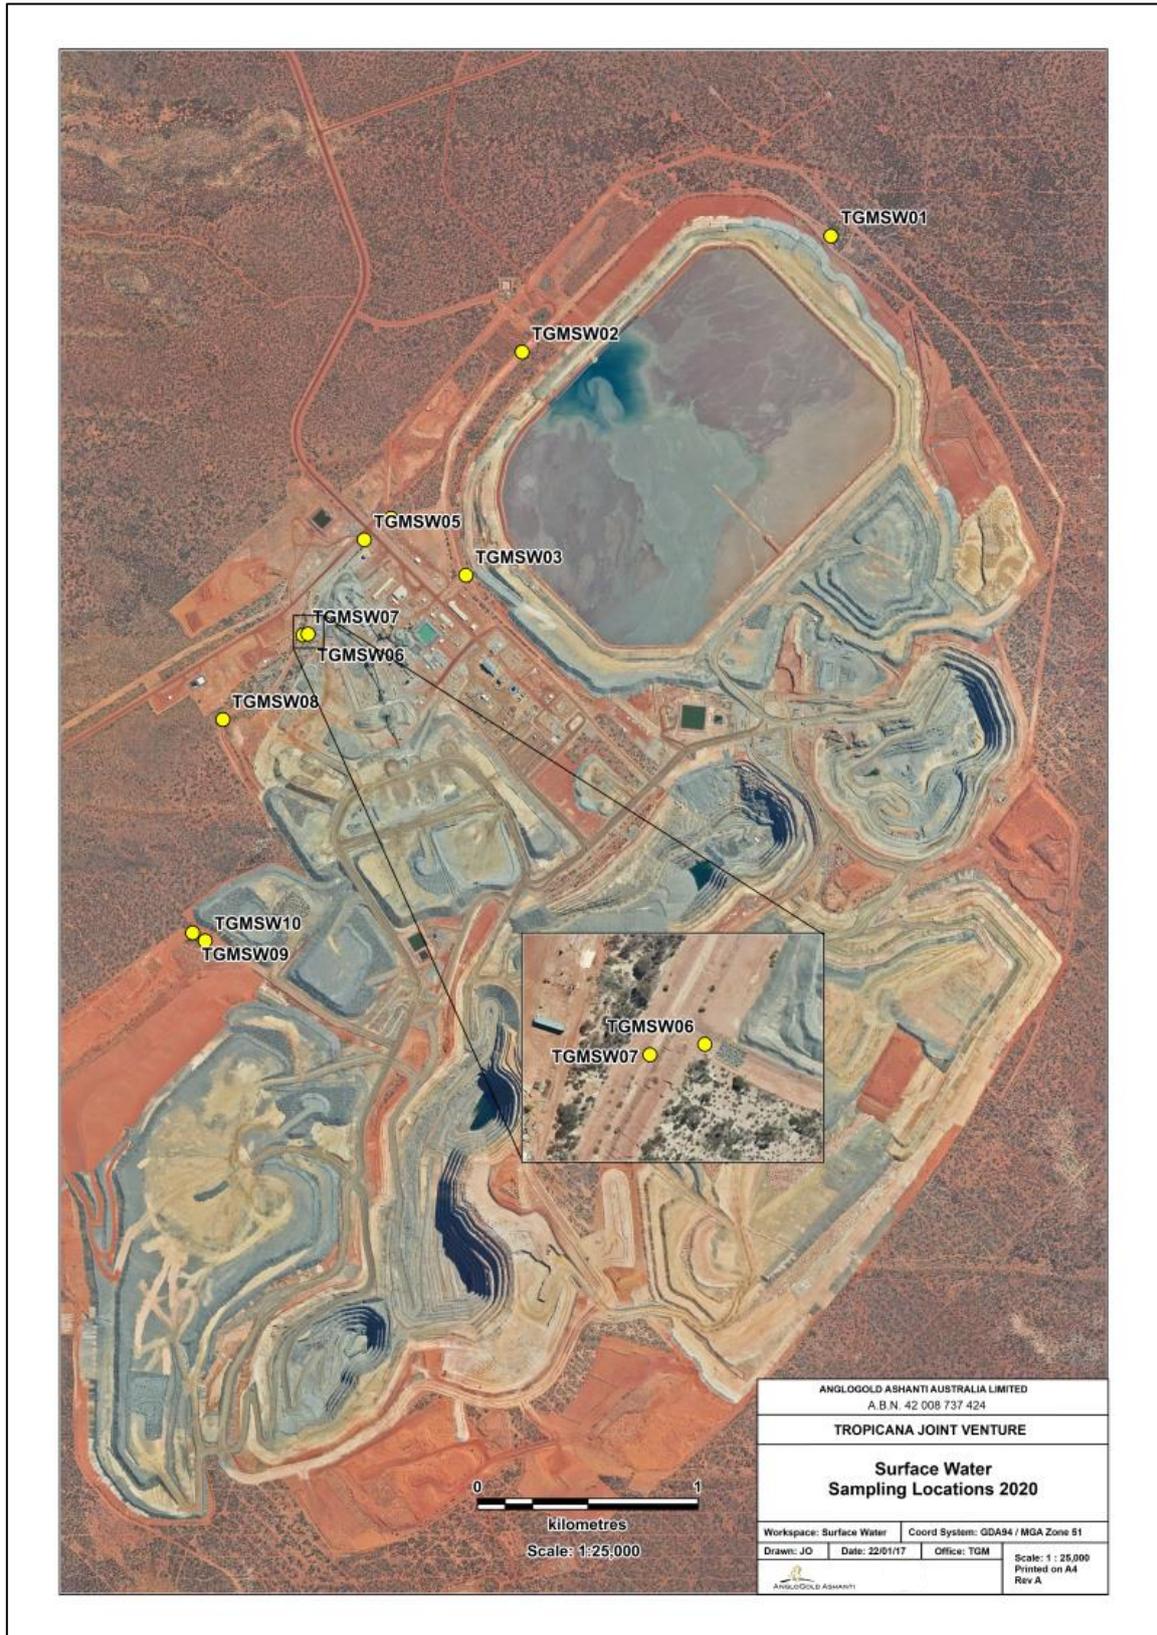
Figure 5: Storm Water Monitoring Locations

Stormwater (previously referred to as surface water) monitoring sites have been established around the TSF and waste landforms (Figure 5) as required by Condition 8.2. Due to the absence of continuous standing surface water, samples from these locations have only been obtained following rainfall events where there is stormwater runoff (>20 mm rainfall in 24 hours). Results from stormwater sampling locations are provided in Appendix D.

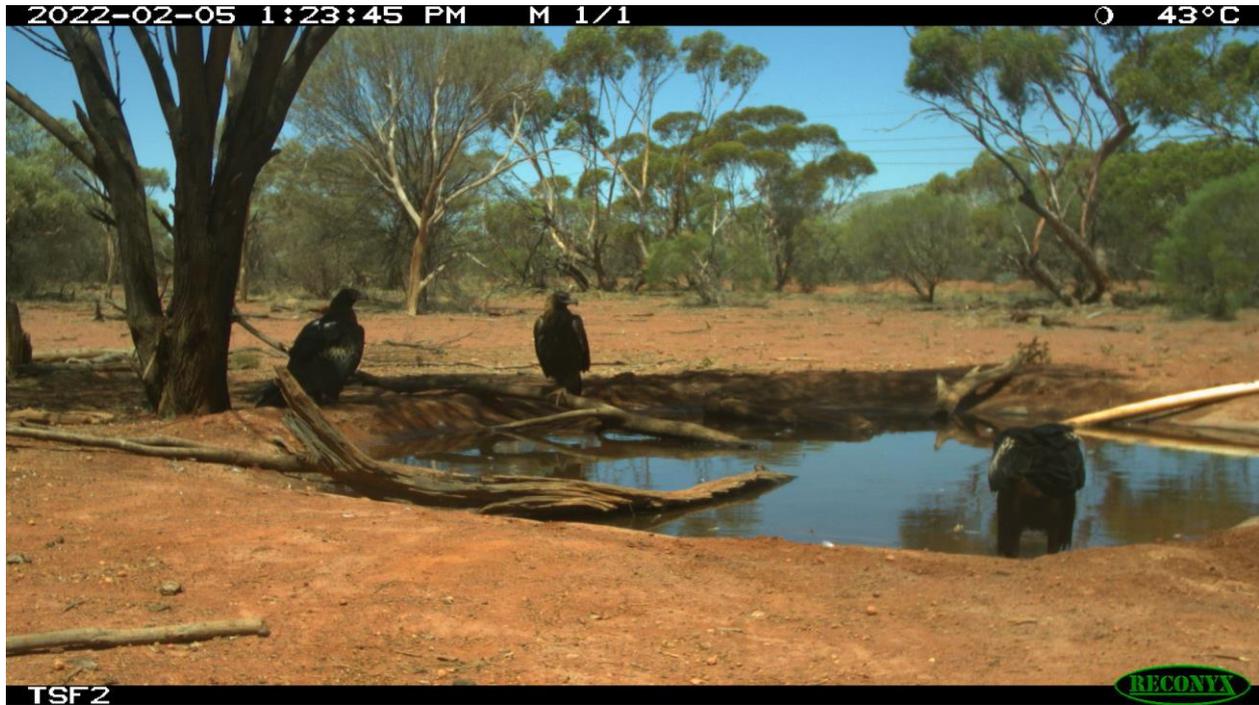
Plate 1: Photo monitoring of TSF artificial water sources [TSF ART 2] – Wedge tailed Eagles (February 2022)

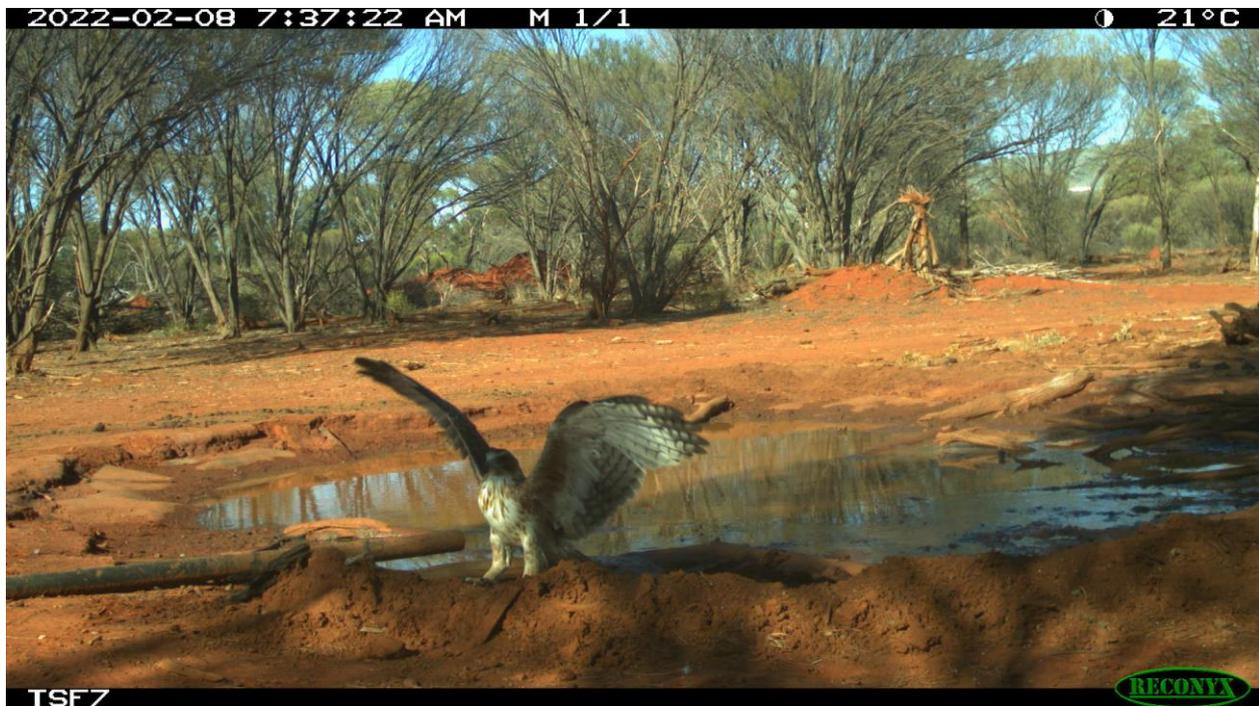
Plate 2: Photo monitoring of TSF artificial water sources [TSF ART 7] – Peregrine Falcon (February 2022)

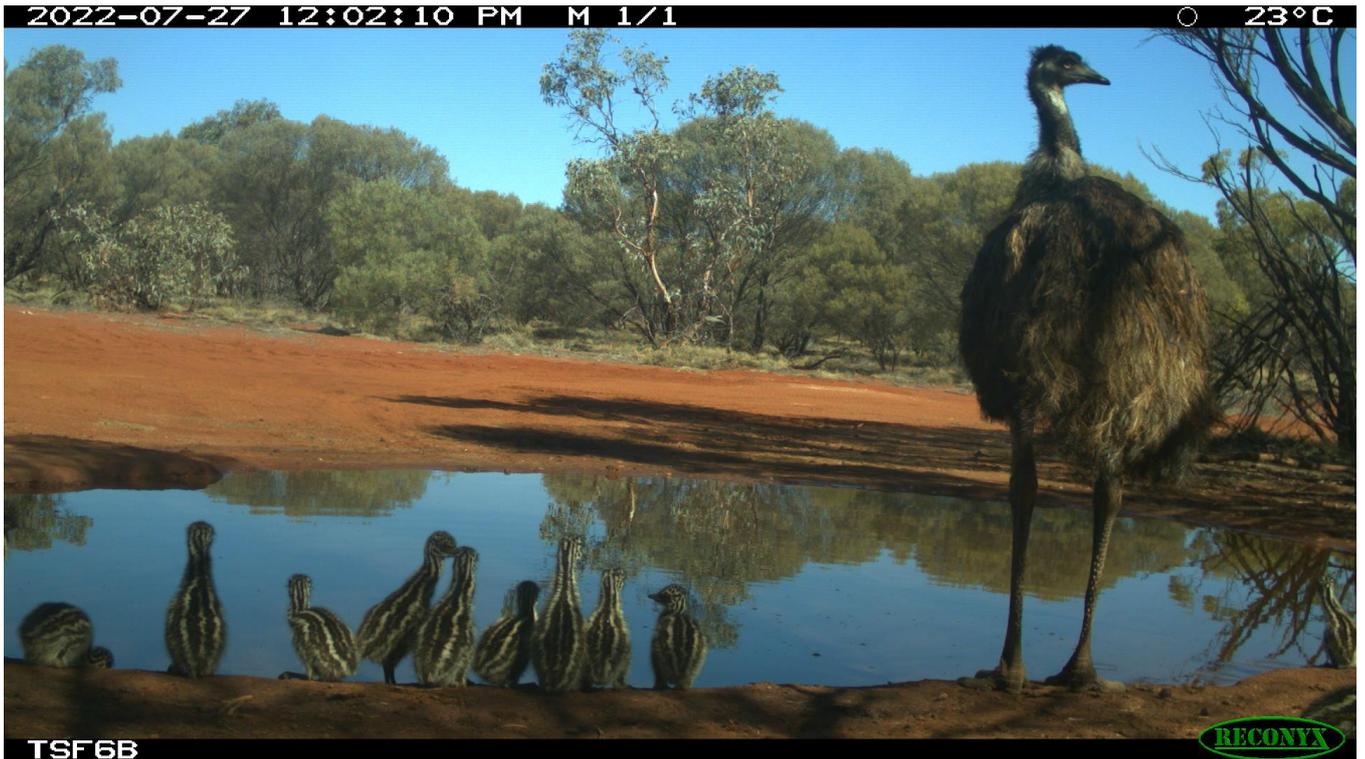
Plate 3: Photo monitoring of TSF artificial water sources [TSF ART 6] – Emus (July 2022)

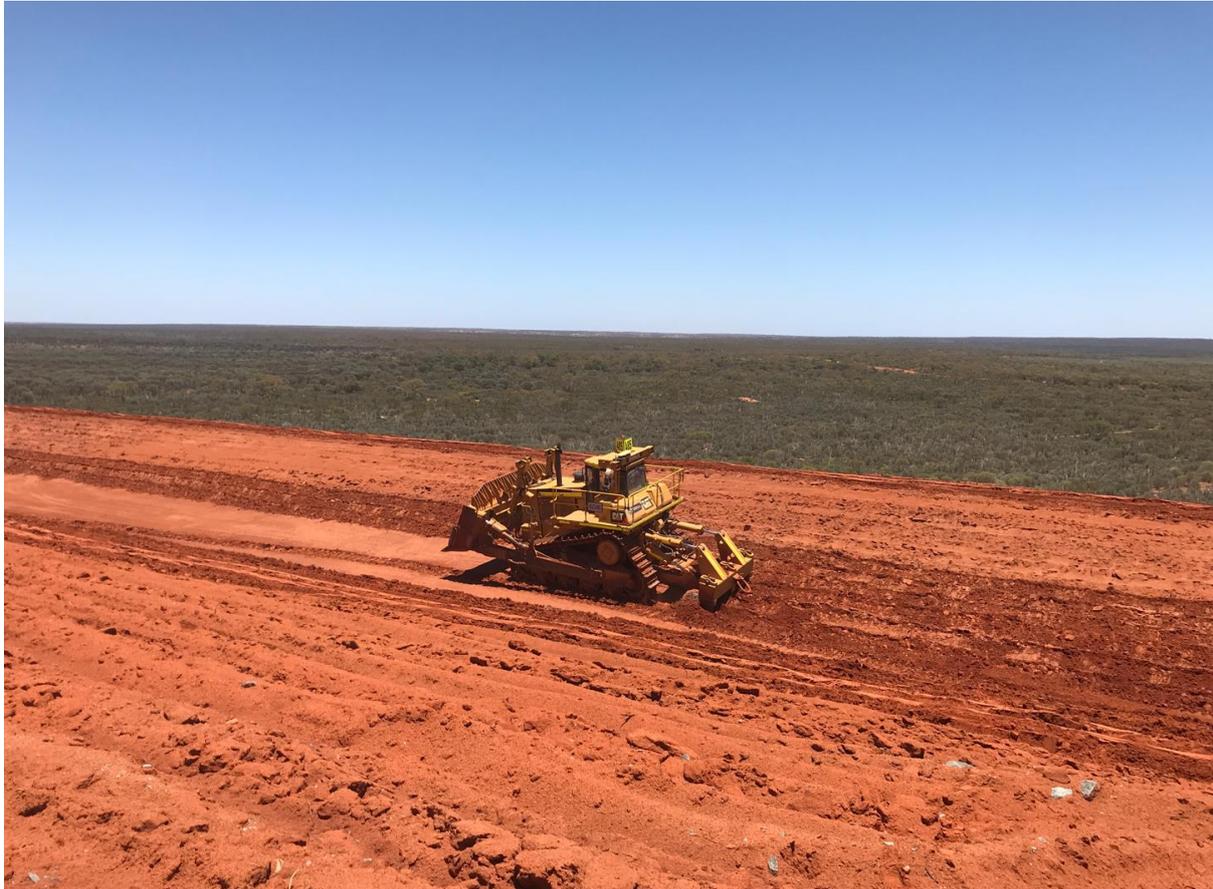
During the reporting period, rehabilitation earthworks were completed on a section of the LWE waste landform. Earthworks were undertaken over an approximately 13 ha area to construct waste landform batter slopes at 15° as per the TGM waste landform rehabilitation design. Growth medium was spread to a depth of 500 mm, contour ripped and hand-seeded with local provenance species.

Figure 1: Waste landform batter slope progressive rehabilitation.

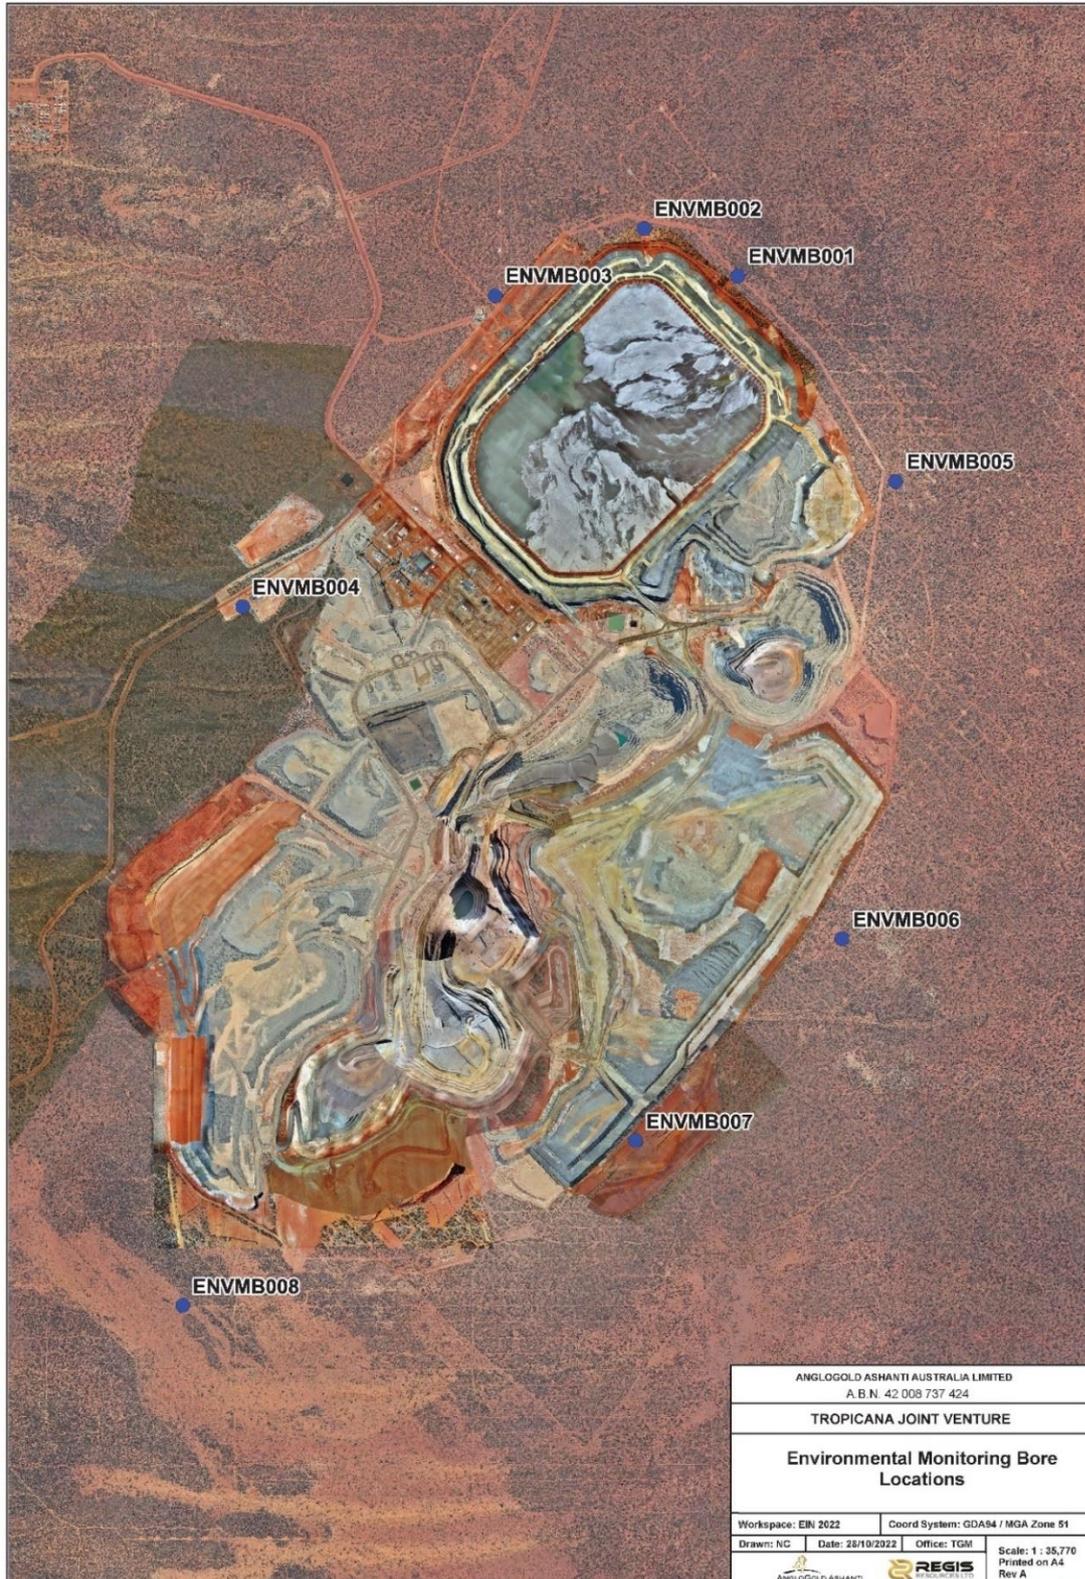
Figure 1 ENVMB001-008 Locations

Groundwater monitoring from the eight monitoring bores installed around the TSF and waste landform footprints (Figure 4) continued throughout the reporting period. A summary of results from the sampling events are provided in Appendix C. Results obtained from these monitoring bores were compared against trigger values which were established in 2014. Analysis of results indicates that changes in groundwater quality (baseline groundwater quality +/- 10%) has occurred at some monitoring bores.

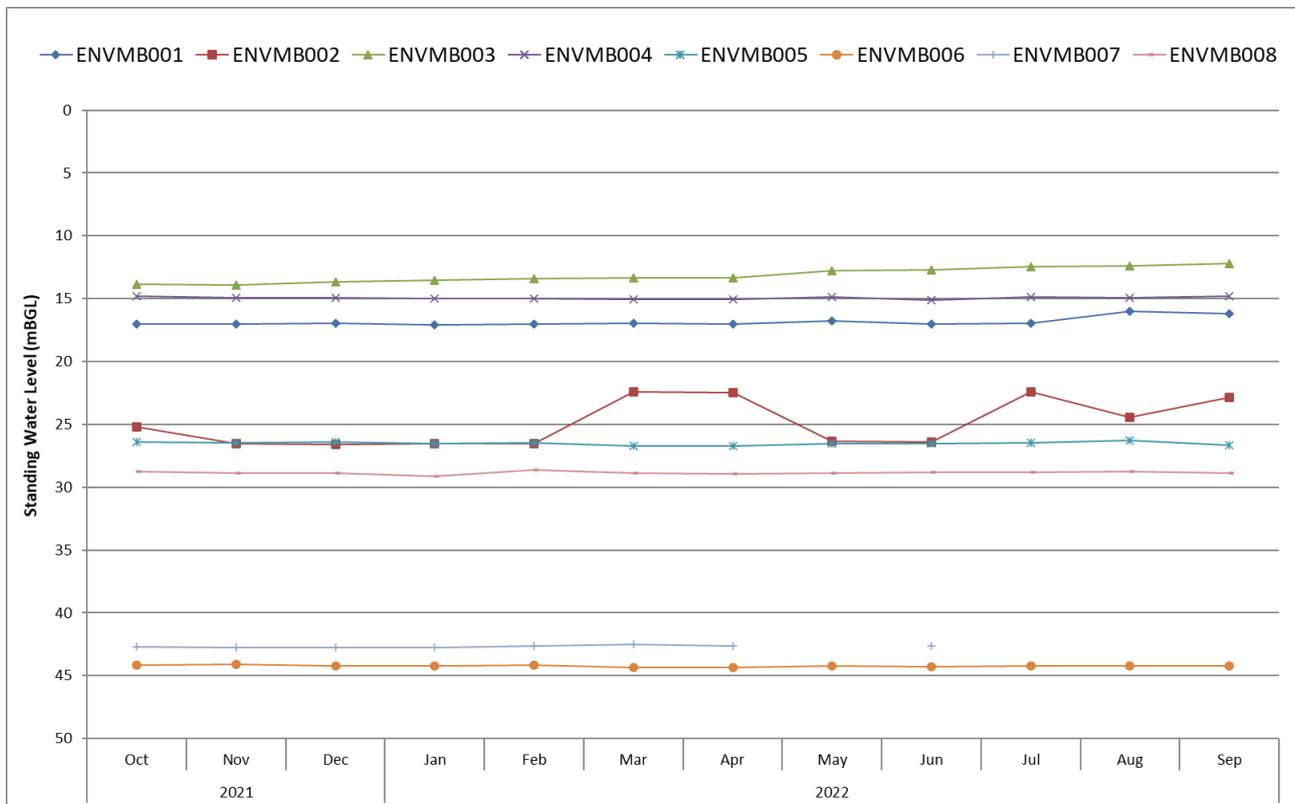
- To the north of the TSF, ENVMB001 and ENVMB002 reported rises in groundwater of 0.81 m and 2.36 m respectively over the reporting period. These variations have been attributed to the TSF recovery bores on the north side of the TSF being intermittently shut off for the TSF wall lift that was ongoing during the period, plus bore field optimisation and servicing.
- ENVMB003 (west of the TSF) reported a 1.66 m rise in groundwater level over the reporting period, which has been attributed to the TSF recovery bores to the west of the TSF being decommissioned for the TSF waste landform extension.
- Monitoring bores ENVMB004-008 reported water level fluctuations of less than 0.3 m over the reporting period.

Figure 2 Groundwater Levels in Environmental Monitoring Bores October 2021 – September 2022

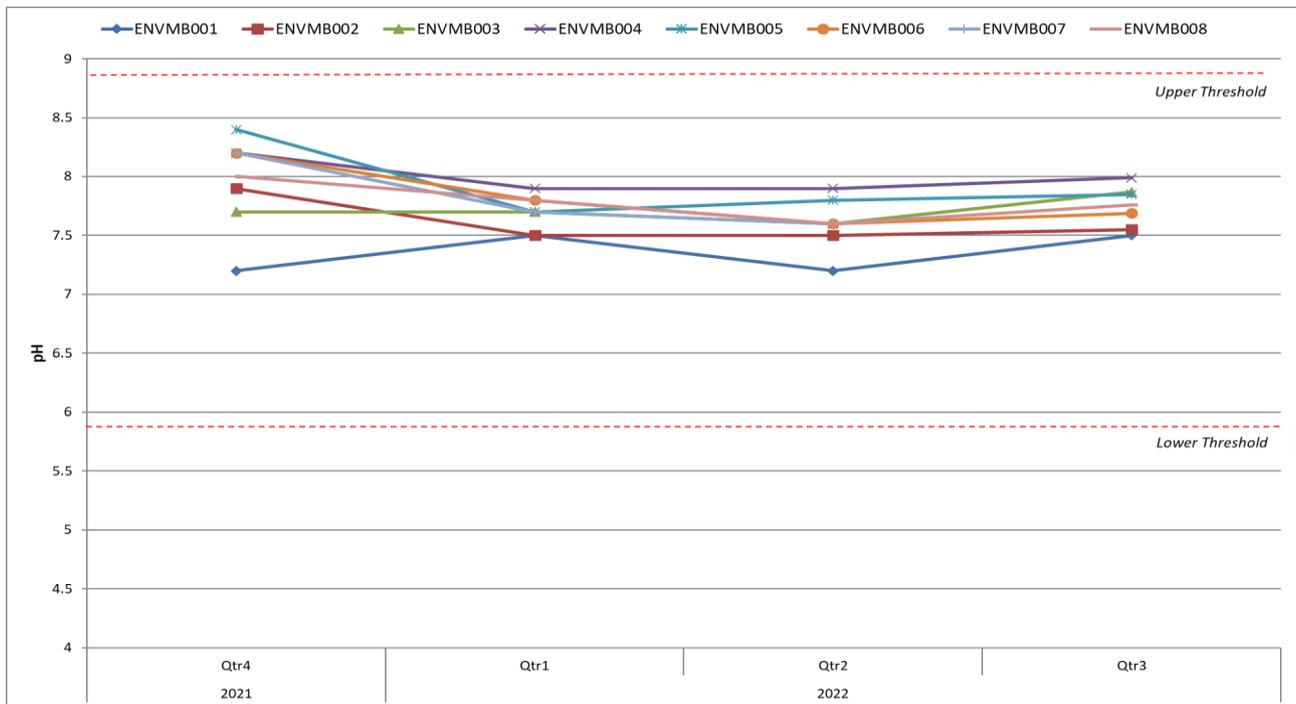
Laboratory pH results (Figure 3) in all bores remained within the trigger level thresholds for the reporting period and remain consistent with previously reported results.

Figure 3 Laboratory pH in Environmental Monitoring Bores Q4 2021 to Q3 2022

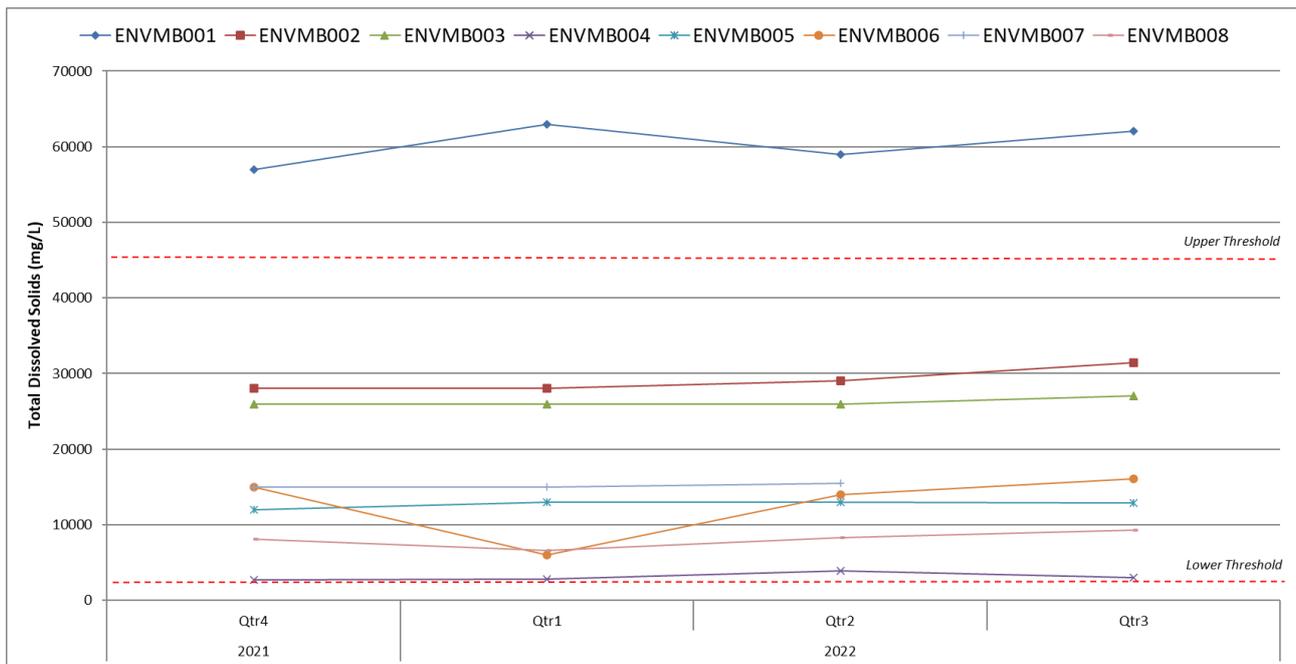
- ENVMB001 (north of the TSF) remained hypersaline and above the upper trigger value, as in previous periods;
- ENVMB002-003 and 005-008 were all within trigger value thresholds, ranging from saline to hypersaline and were consistent with previous years; and
- ENVMB004 was reported at, or slightly below, the lower trigger value and is in the brackish range. This represents the lower limit of salinity within the operational area, in the up-hydraulic gradient portion of the paleochannel system flowing broadly northward to the Salt Lake system north of the process water supply borefield.

Figure 4 Total Dissolved Solids in Environmental Monitoring Bores Q4 2021 – Q3 2022

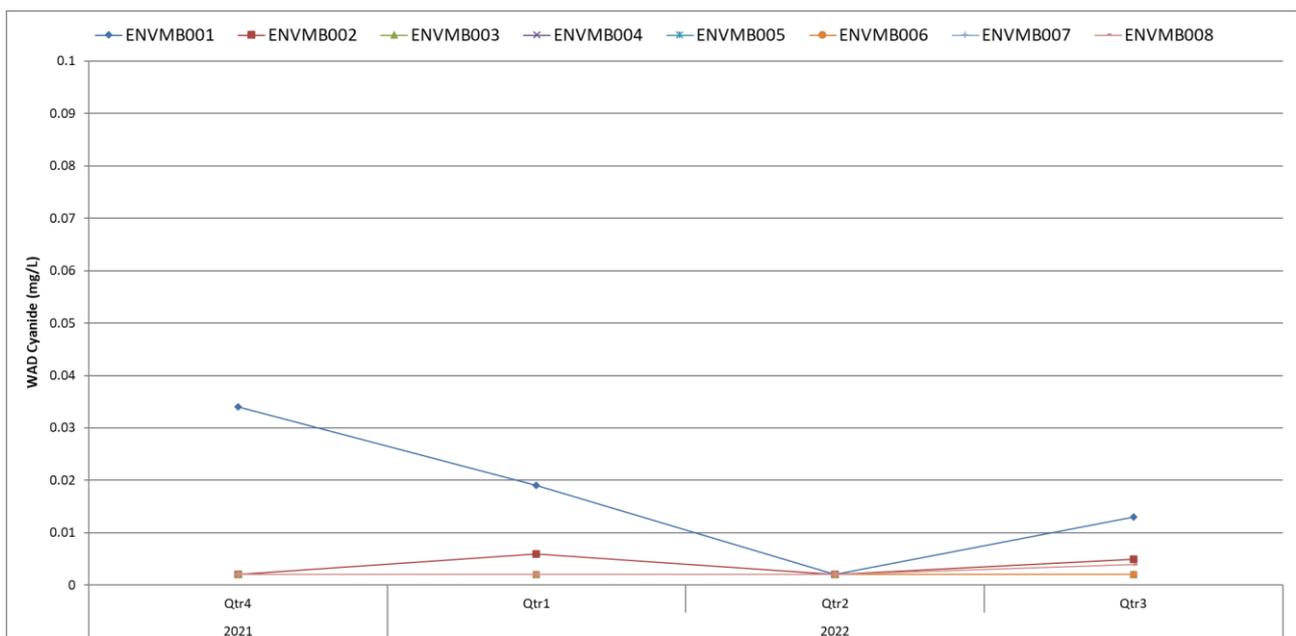
- WAD cyanide was not reported above the laboratory limit of reporting (LOR) in bores ENVMB003-008;
- WAD CN was reported at concentrations between 0.034 mg/L and LOR at ENVMB001 during the reporting period, which is a comparable to 2021 results. This monitoring bore is directly down-hydraulic gradient from the TSF and within the cone of depression of abstraction bores in this area;
- WAD CN was reported at concentrations between 0.006 mg/L and LOR at ENVMB002 during the reporting period however this remains consistent with previously reported values for this bore.

Figure 5 WAD Cyanide in Environmental Monitoring Bores Q4 2021 – Q3 2022

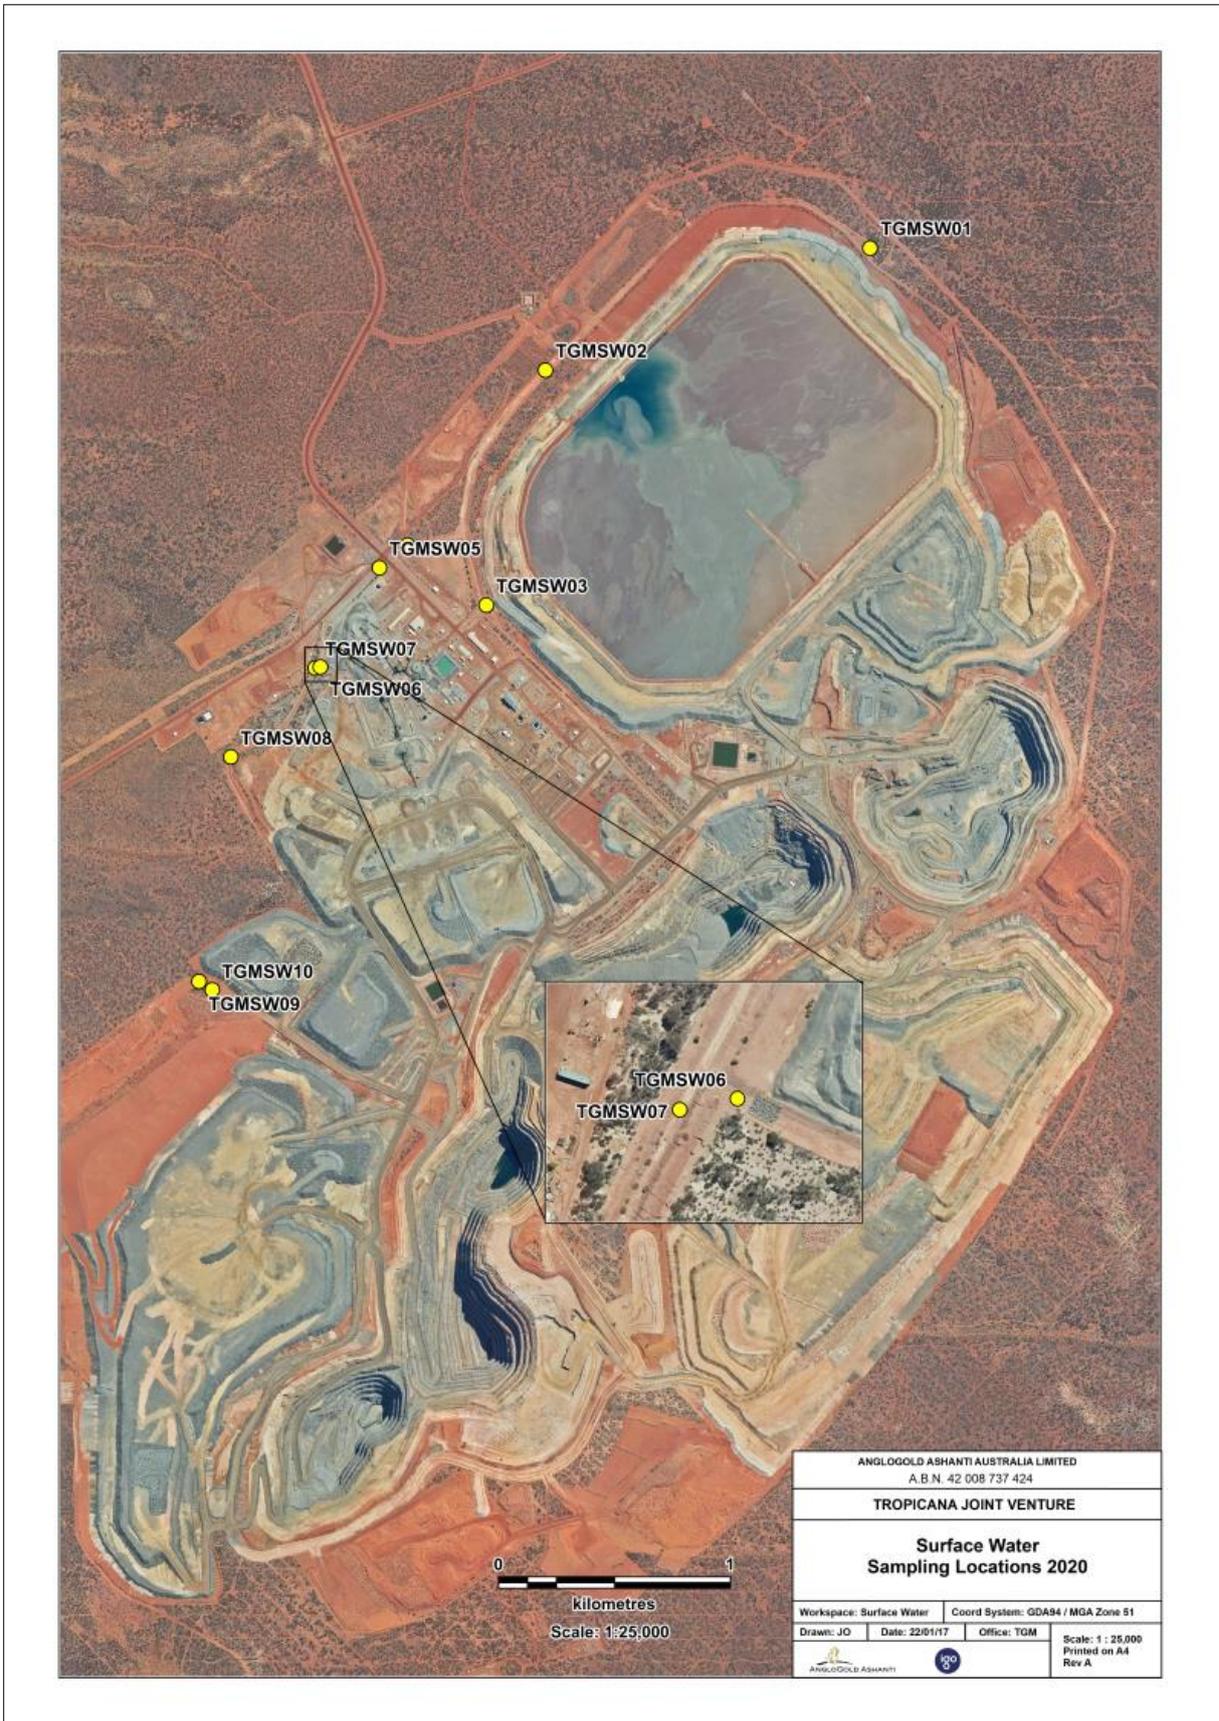
Figure 1 Stormwater Sampling Locations

Monitoring Point	Description
TGMSW01	Diversion Drain - Northern side of TSF
TGMSW02	Diversion Drain - Western side of TSF
TGMSW03	Diversion Drain - Southern side of TSF
TGMSW04	Diversion Drain - Western side of Geology Laydown
TGMSW05	Diversion Drain - Village Access Road
TGMSW06	Diversion Drain - Fine Ore Stockpile
TGMSW07	Diversion Drain - Fine Ore Stockpile
TGMSW08	Diversion Drain - Eastern side of Twin Turkey Nest
TGMSW09	Low Point within Active Mining Area
TGMSW10	Low Point within Active Mining Area
