Tropicana Gold Project Ministerial Statement No. 839 – 2020/2021 Annual Compliance Assessment Report.

Tropicana Joint Venture
Tropicana Gold Mine (TGM)
Ministerial Statement No 839
Annual Compliance Assessment Report
24 September 2020 to 23 September 2021

Tropicana Gold Project, Annual Compliance Assessment Report

Ministerial Statement No. 839

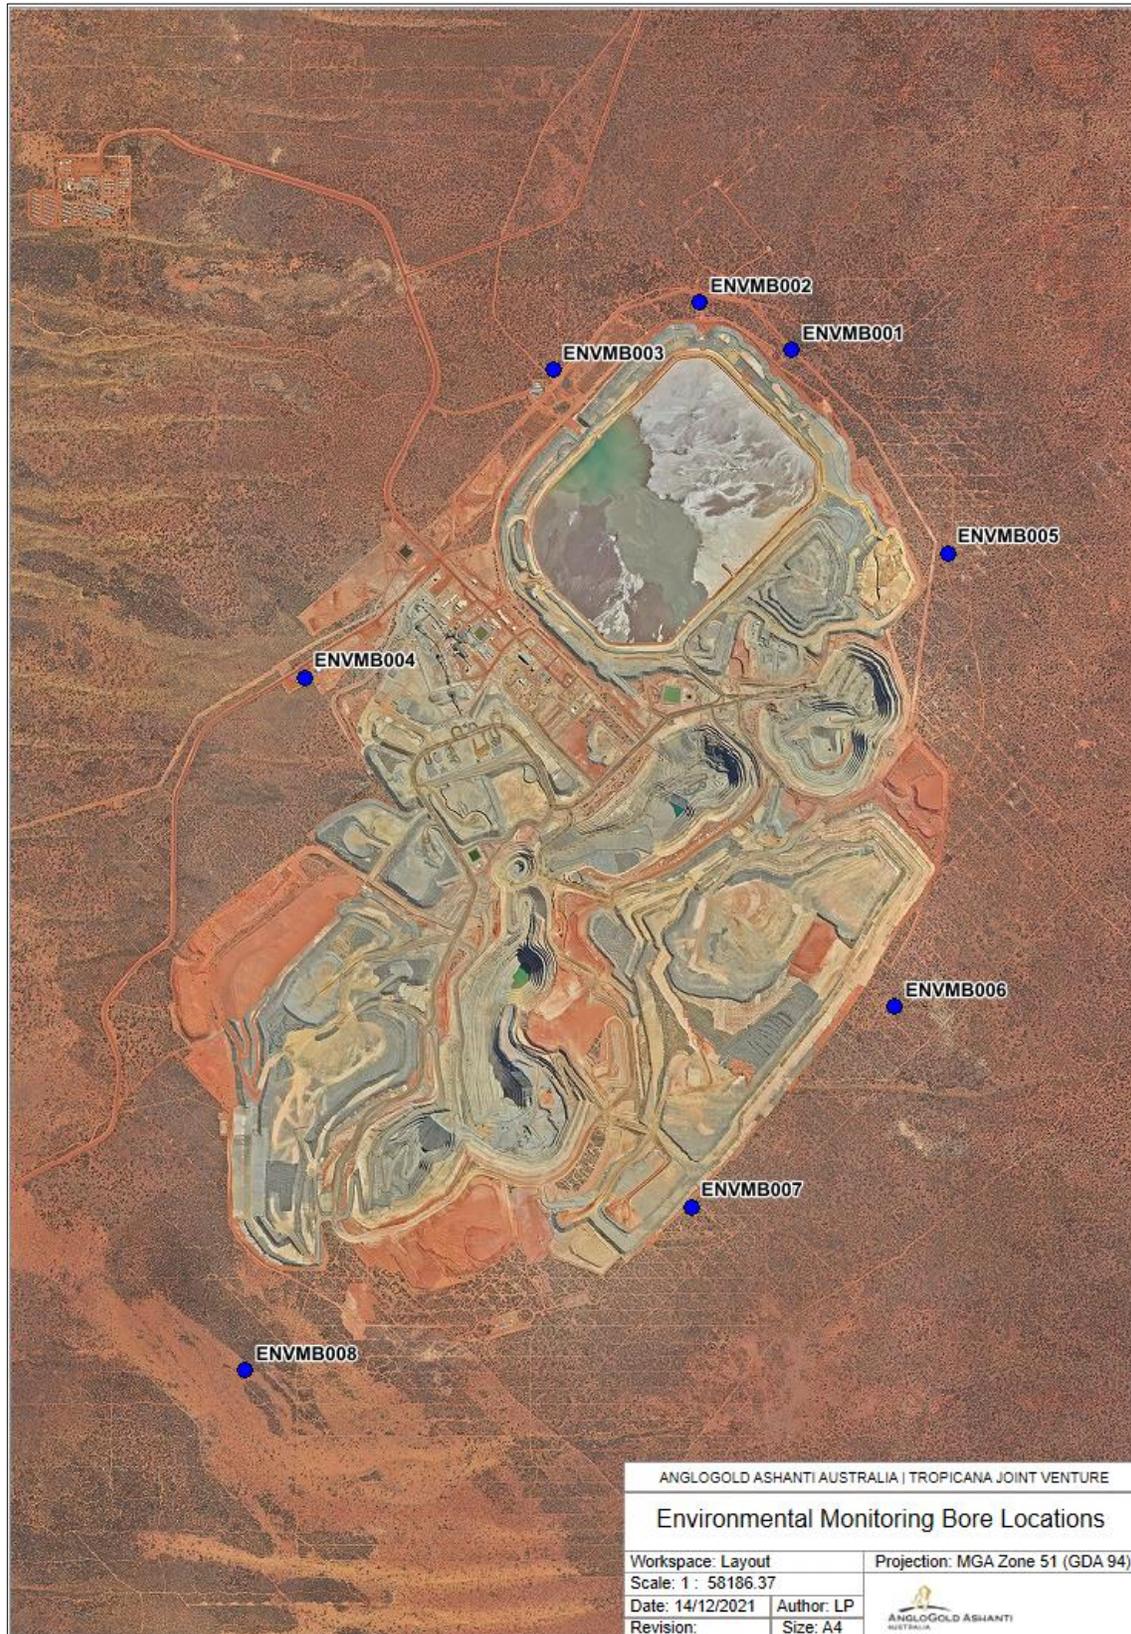
Figure 4: MS839 Groundwater Monitoring Bore Locations

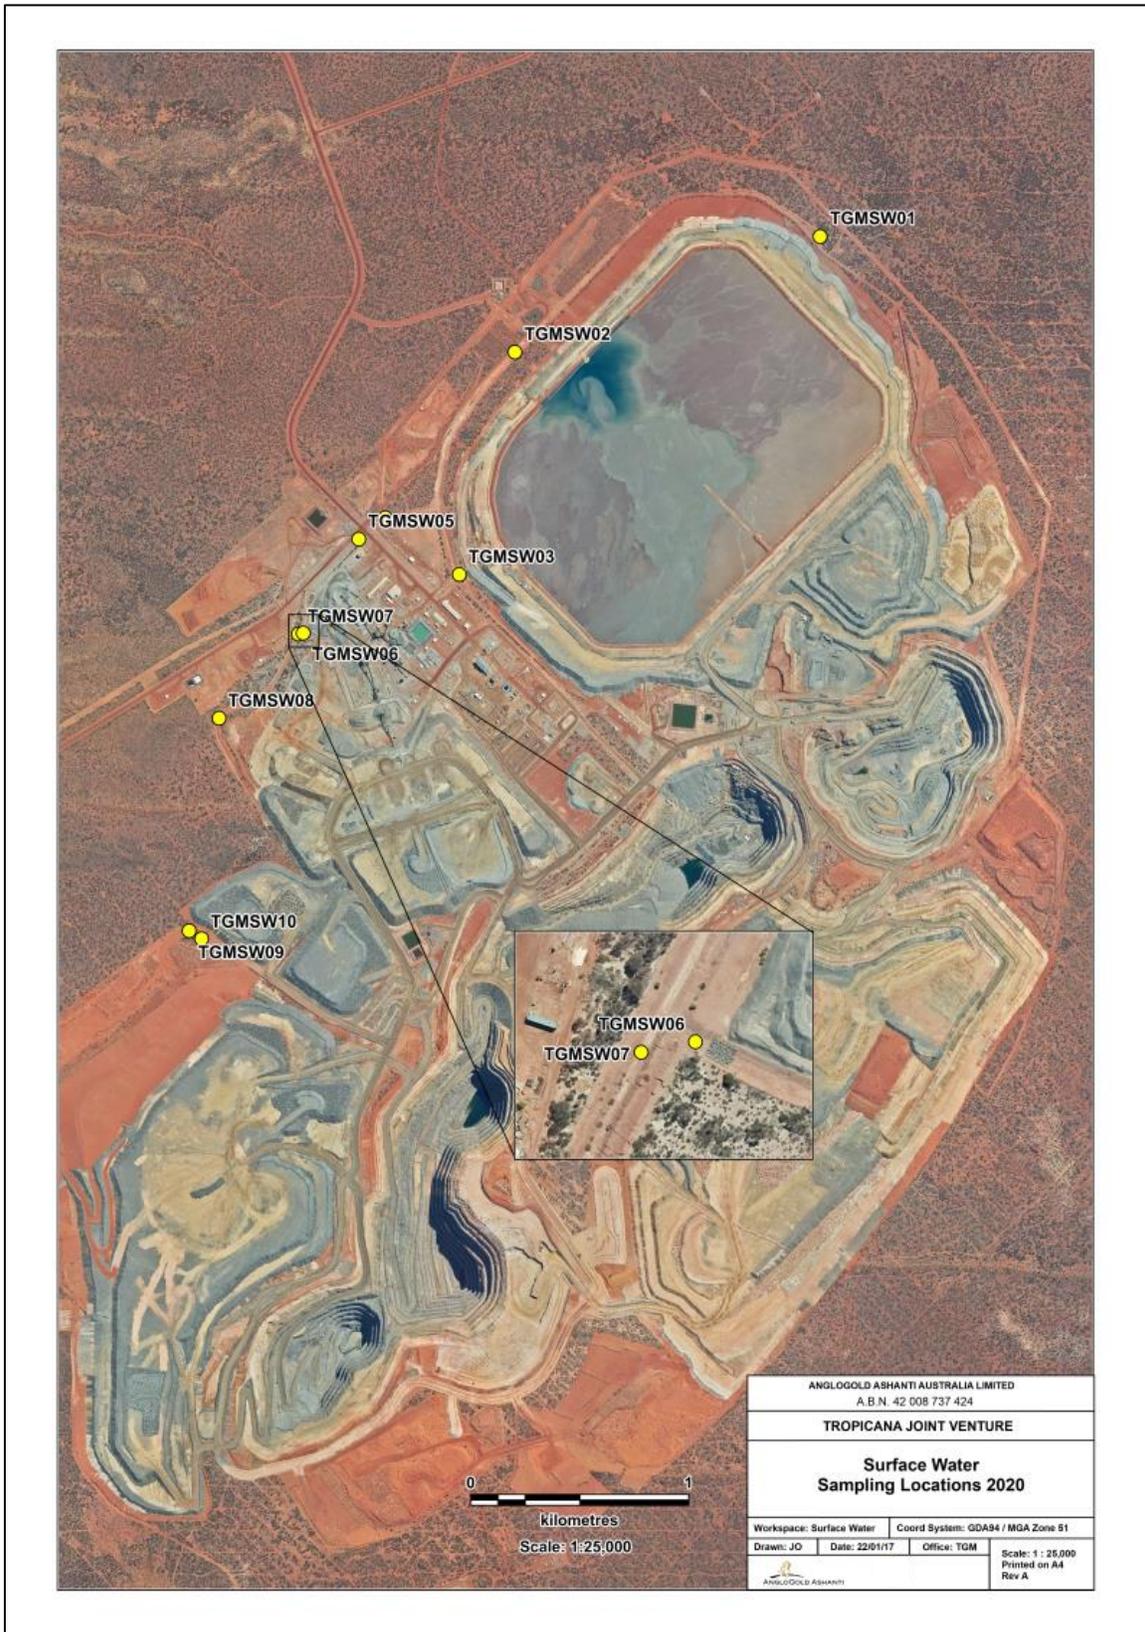
Stormwater (previously referred to as surface water) monitoring sites have been established around the TSF and waste landforms (Figure 5) as required by Condition 8.2. Due to the absence of continuous standing surface water, samples from these locations have only been obtained following rainfall events where there is stormwater runoff (>20 mm rainfall in 24 hours). Results from stormwater sampling locations are provided in Appendix D.

Figure 5: Storm Water Monitoring Locations

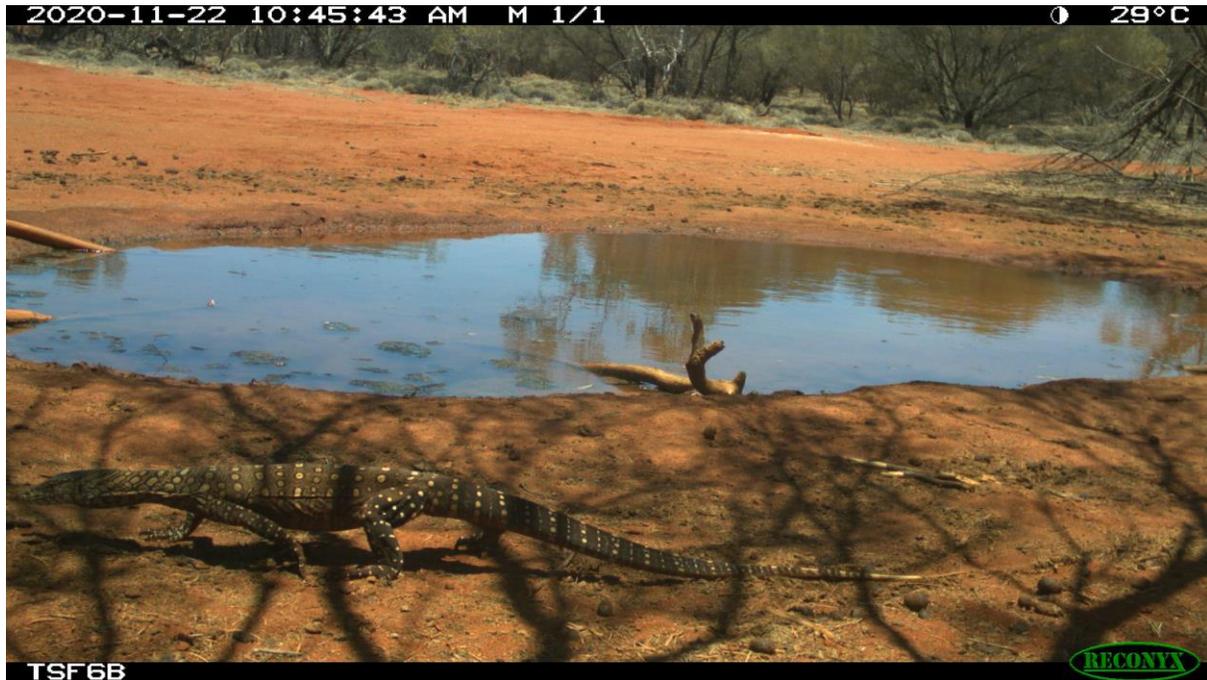
Plate 1: Photo monitoring of TSF artificial water sources [TSF ART 6] – Perentie (November 2020)

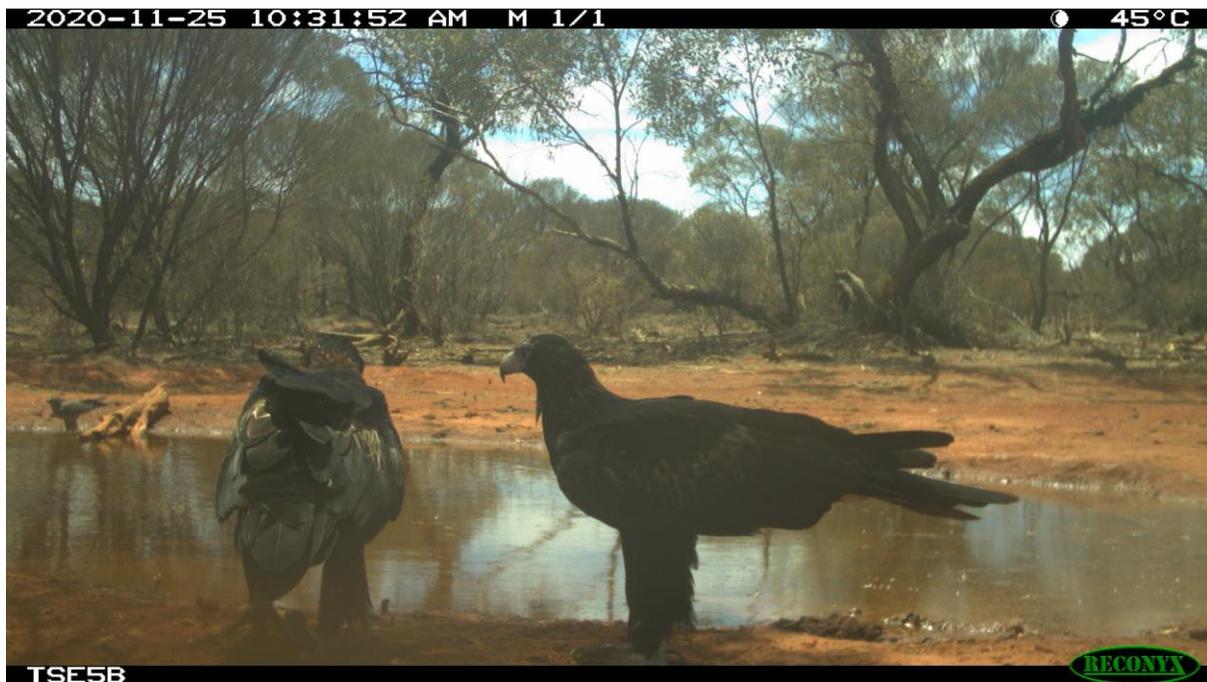
Plate 2: Photo monitoring of TSF artificial water sources [TSF ART 5] – Wedge Tailed Eagles (November 2020)

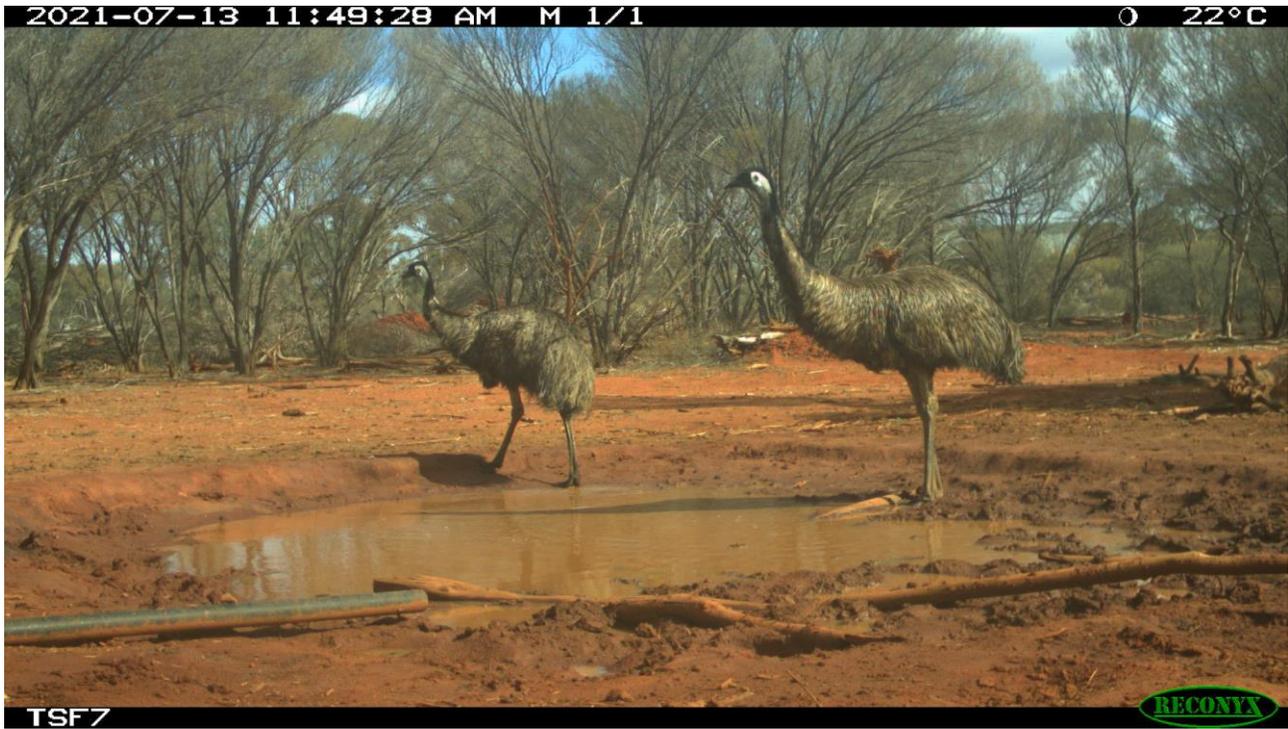
Plate 3: Photo monitoring of TSF artificial water sources [TSF ART 7] – Emus (July 2021)

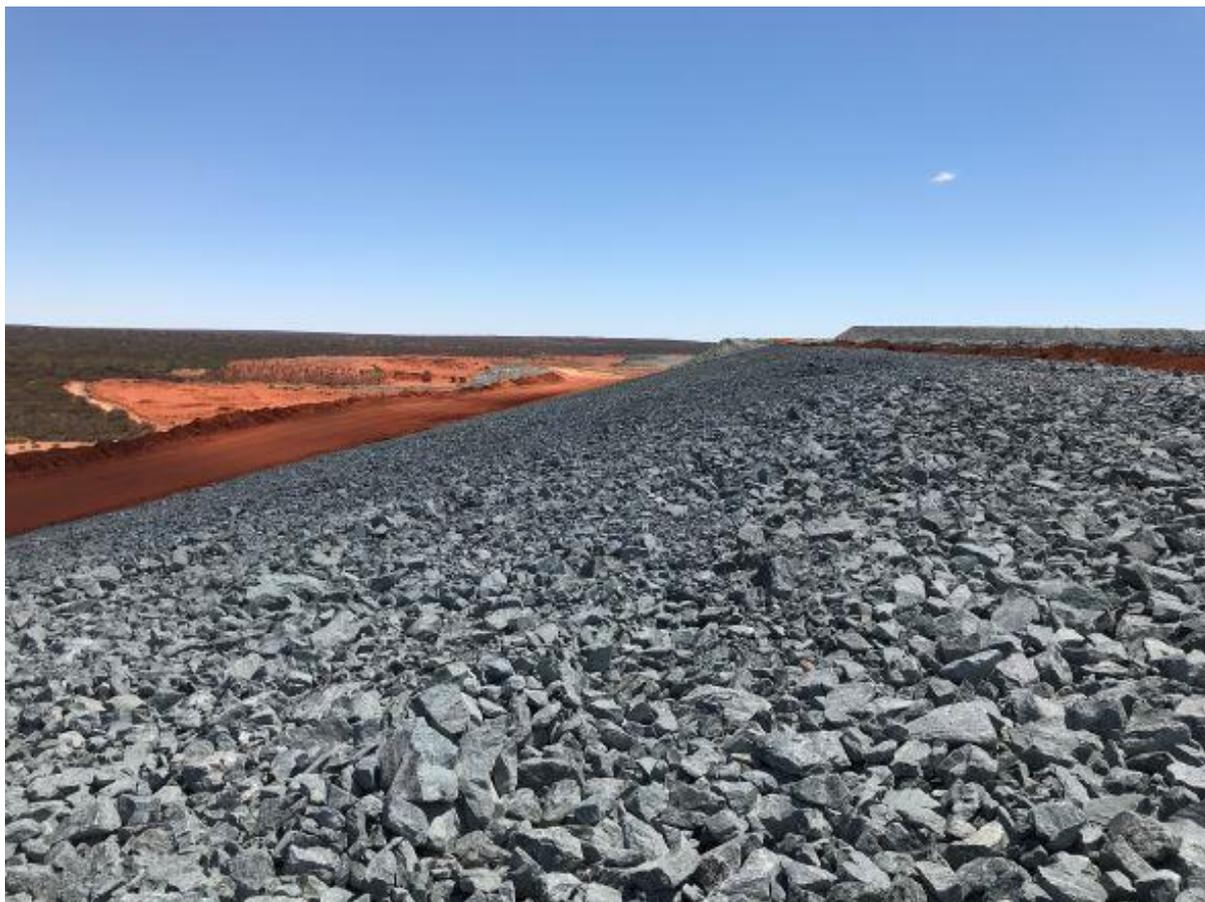
During the reporting period, primary rehabilitation earthworks were completed on a section of the LWE waste landform. Primary earthworks were undertaken over an approximately 15 ha area to construct waste landform batter slopes at 15° as per the TGM waste landform rehabilitation design.

Figure 1: Waste landform batter slope progressive rehabilitation.

The application of growth medium, contour ripping and seeding of the waste landform will be undertaken in the 2021/2022 reporting period.

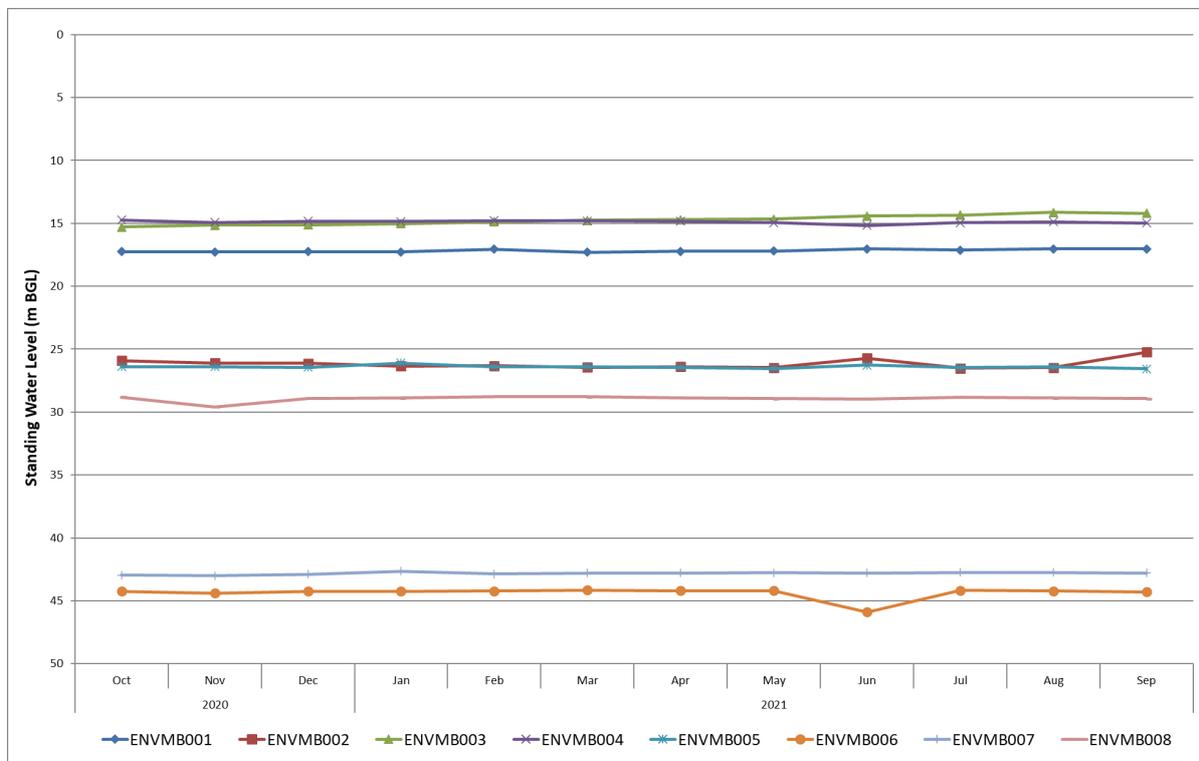
- Monitoring bores ENVMB004-008 reported water level fluctuations of less than 0.5 m over the reporting period;
- ENVMB003 (west of the TSF) reported a 1.08 m rise in groundwater level; and
- ENVMB002 fluctuated over the reporting period, with an overall rise of 0.68 m in response to abstraction bore pumping.

Figure 1 Groundwater Levels in Environmental Monitoring Bores 2020-2021 Reporting Period

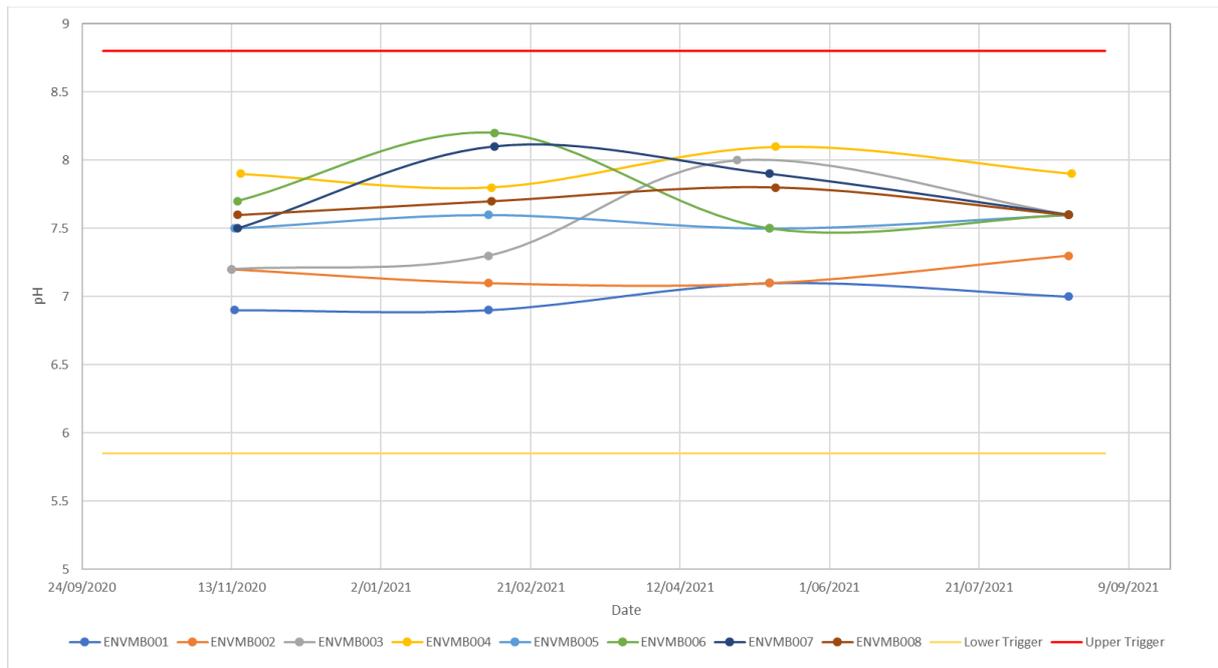
- pH in all bores was within trigger level thresholds during the reporting period.

Figure 2 Laboratory pH in Environmental Monitoring Bores 2020-2021 Reporting Period

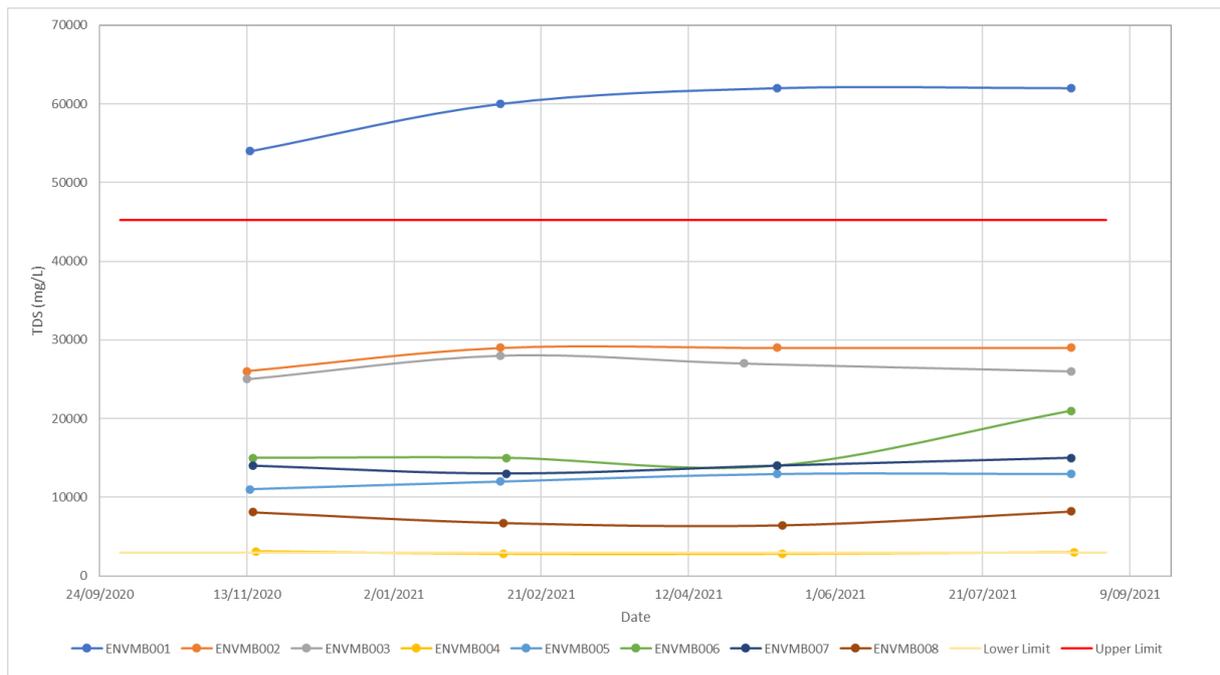
- ENVMB004 was reported at, or slightly below, the lower trigger value and is in the brackish range. This represents the lower limit of salinity within the operational area, in the up-hydraulic gradient portion of the paleochannel system flowing broadly northward to the salt lake system north of the process water supply borefield;
- TDS in ENVMB001 remained hypersaline, and above the upper trigger value, as in previous periods, with a slight upward trend; and
- ENVMB002-003 and 005-008 were all within trigger value thresholds, ranging from saline to hypersaline and were consistent with previous years.

Figure 3 Total Dissolved Solids in Environmental Monitoring Bores 2020-2021 Reporting Period

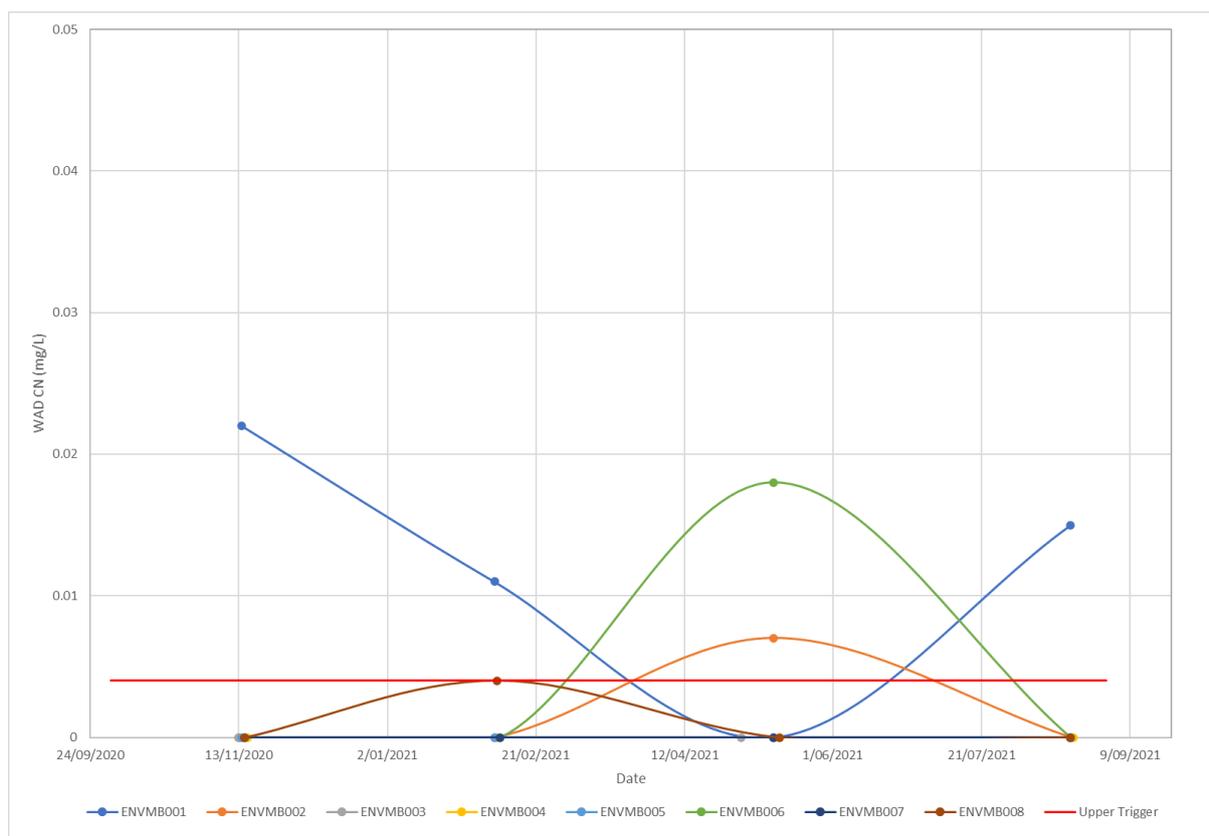
- WAD cyanide was not reported above the laboratory limit of reporting (LOR) in bores ENVMB003-005 and ENVMB007-008;
- WAD CN was reported at concentrations between LOR and 0.022 mg/L at ENVMB001 during the reporting period, which is a comparable frequency to 2020 results. This monitoring bore is directly down-hydraulic gradient from the TSF and within the cone of depression of abstraction bores in this area;
- WAD CN was reported at concentrations between LOR and 0.018 mg/L at ENVMB006 during the reporting period however this remains consistent with previously reported values for this bore.

Figure 4 WAD Cyanide in Environmental Monitoring Bores 2020-2021 Reporting Period

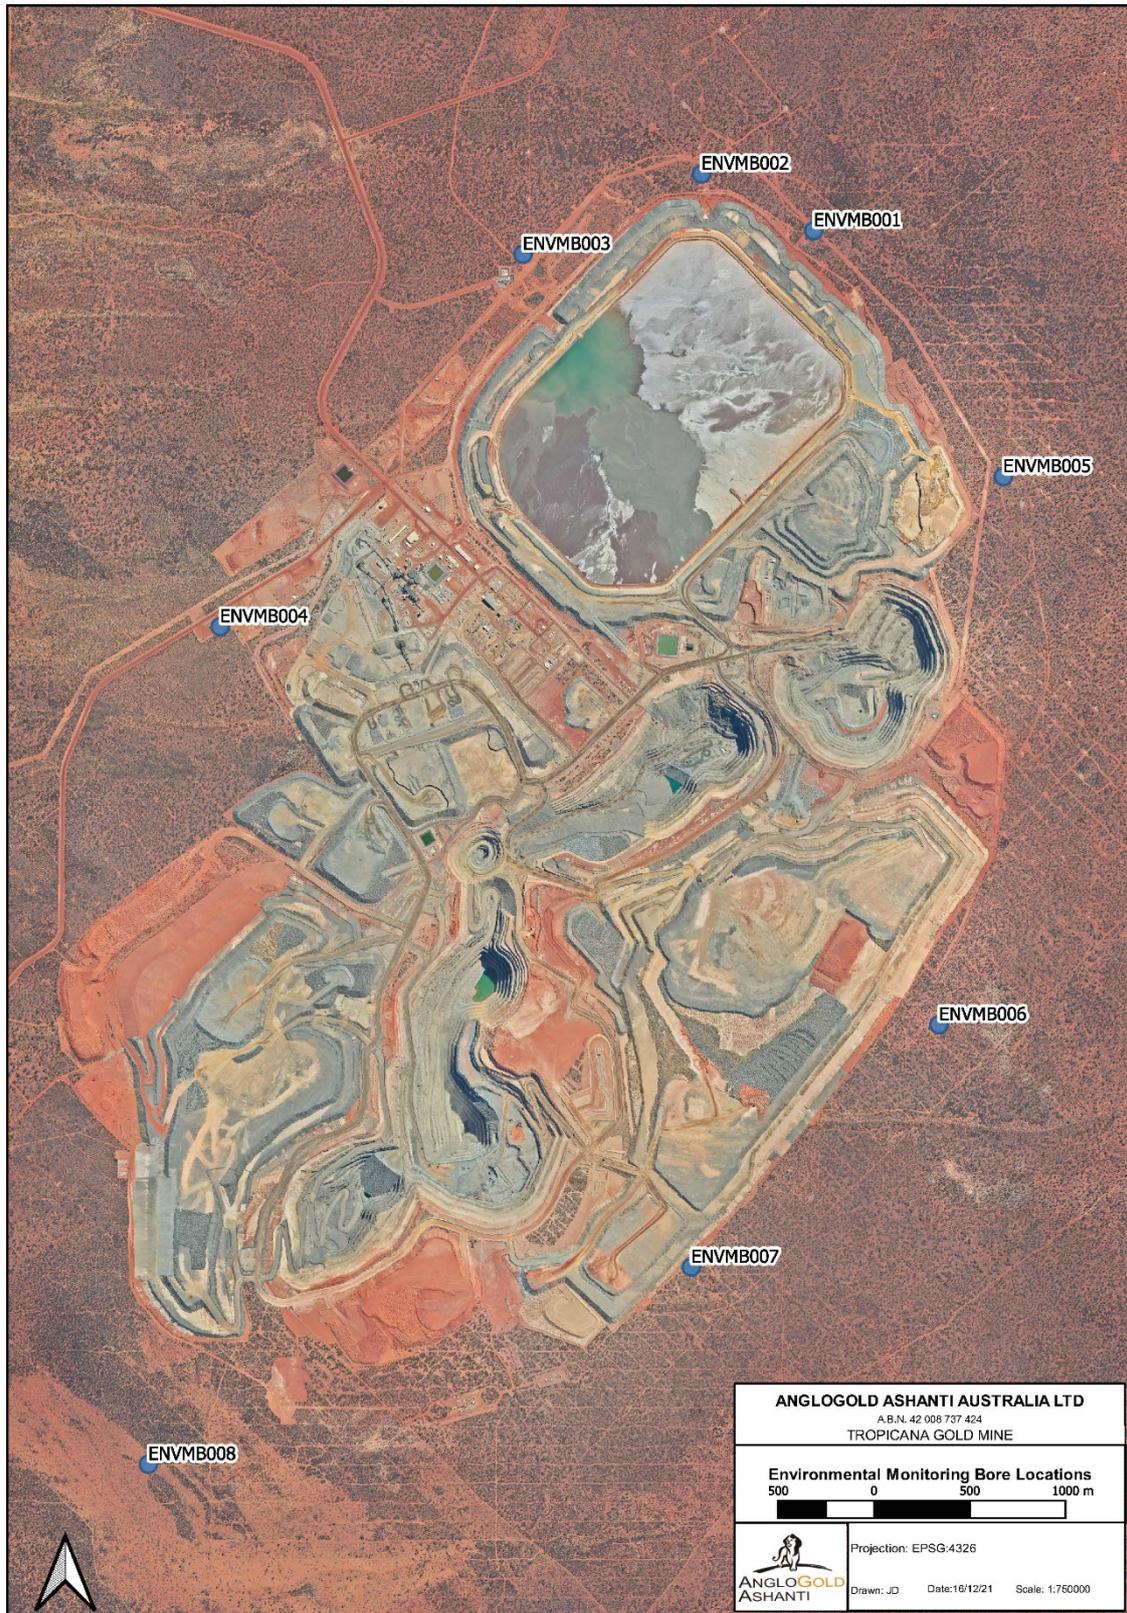
During the reporting period (24 September 2020 – 23 September 2021) eight environmental monitoring bores (ENVMB001 to ENVMB008) water levels were measured on a monthly basis; with water quality samples collected quarterly. Groundwater monitoring of the ENV series monitoring bores has been undertaken since prior to TSF construction and used to establish baseline groundwater conditions with subsequent annual reporting to DWER under MS839. Locations of the ENV series bores is shown in Figure 5 (Attached).

Figure 5 ENVMB001-008 Locations

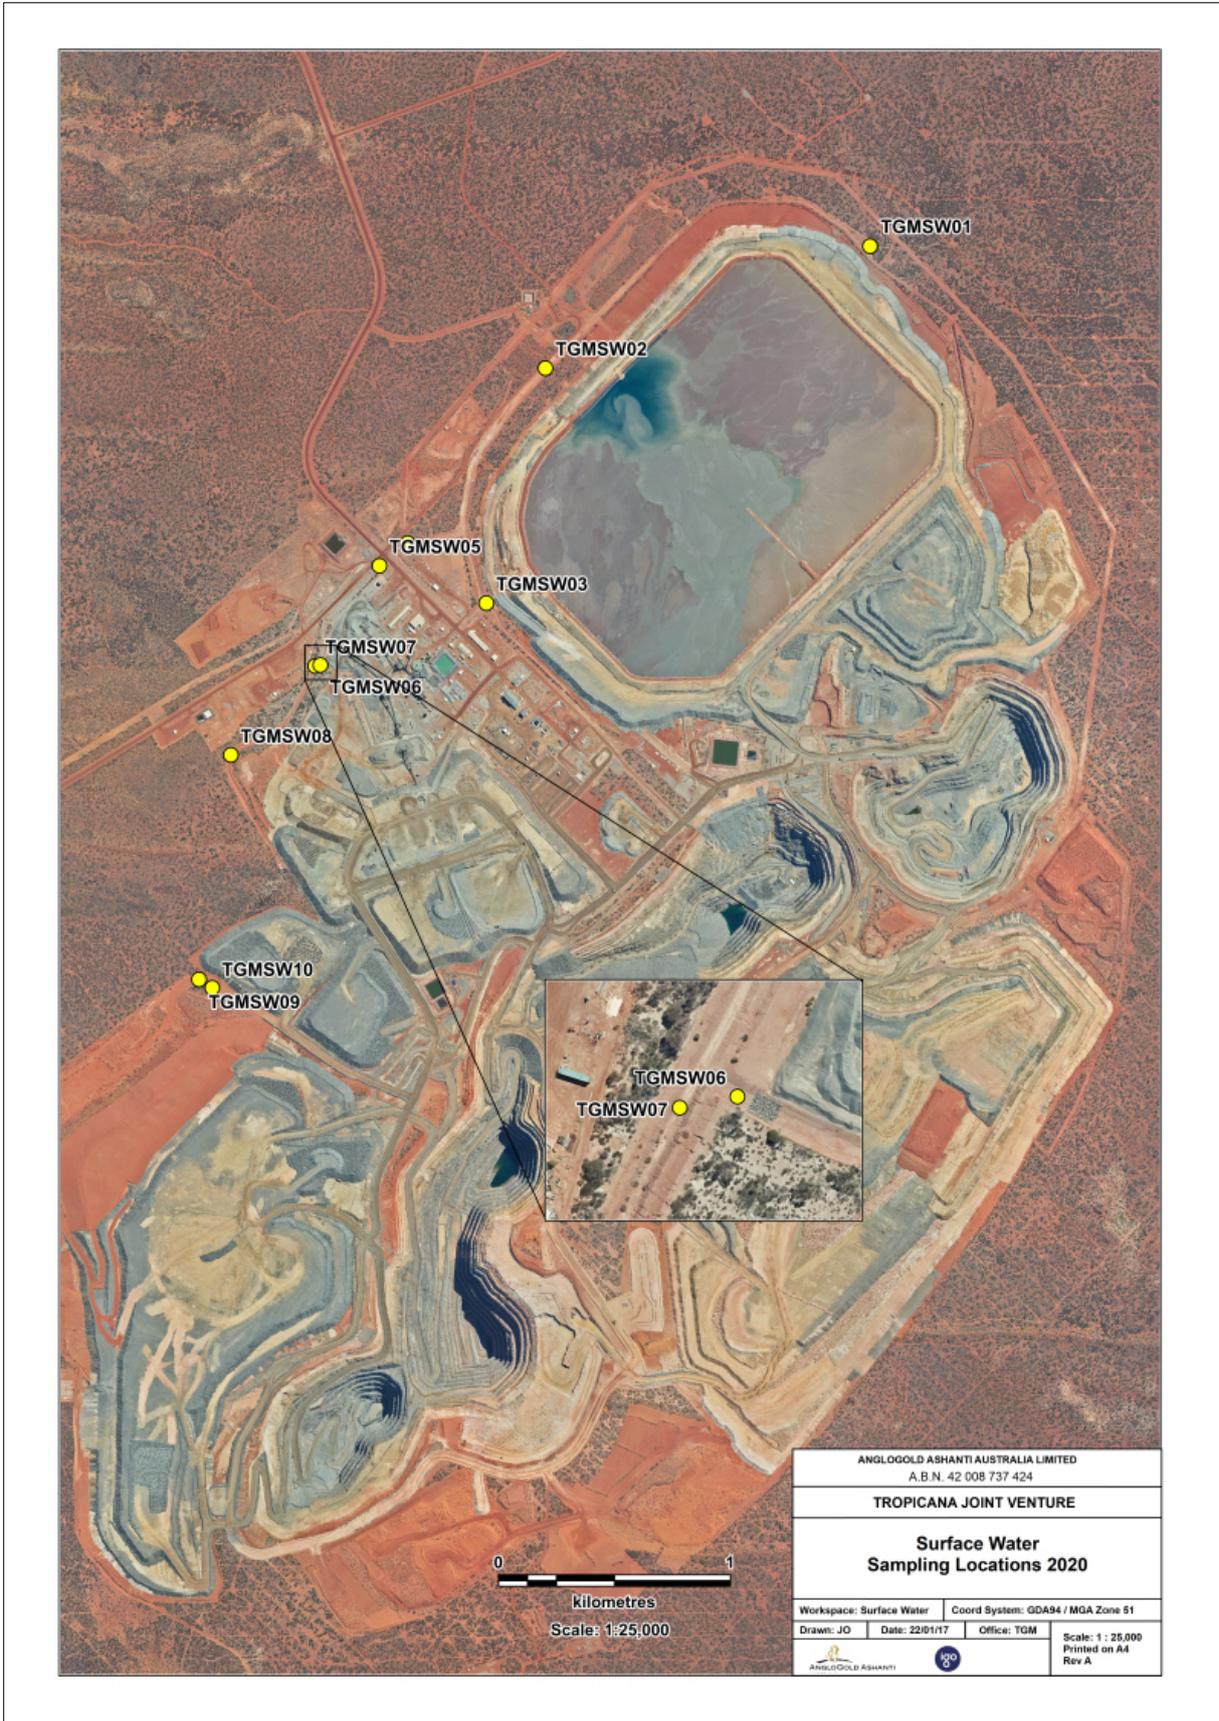
Monitoring Point	Description
TGMSW01	Diversion Drain - Northern side of TSF
TGMSW02	Diversion Drain - Western side of TSF
TGMSW03	Diversion Drain - Southern side of TSF
TGMSW04	Diversion Drain - Western side of Geology Laydown
TGMSW05	Diversion Drain - Village Access Road
TGMSW06	Diversion Drain - Fine Ore Stockpile
TGMSW07	Diversion Drain - Fine Ore Stockpile
TGMSW08	Diversion Drain - Eastern side of Twin Turkey Nest
TGMSW09	Low Point within Active Mining Area
TGMSW10	Low Point within Active Mining Area

Figure 1 Stormwater Sampling Locations
