Tropicana Joint Venture
Tropicana Gold Mine (TGM)
Ministerial Statement No 839
Annual Compliance Assessment Report
24 September 2024 to 23 September 2025

Document Reference: CAR20251224

Tropicana Gold Project, Annual Compliance Assessment Report

Ministerial Statement No. 839

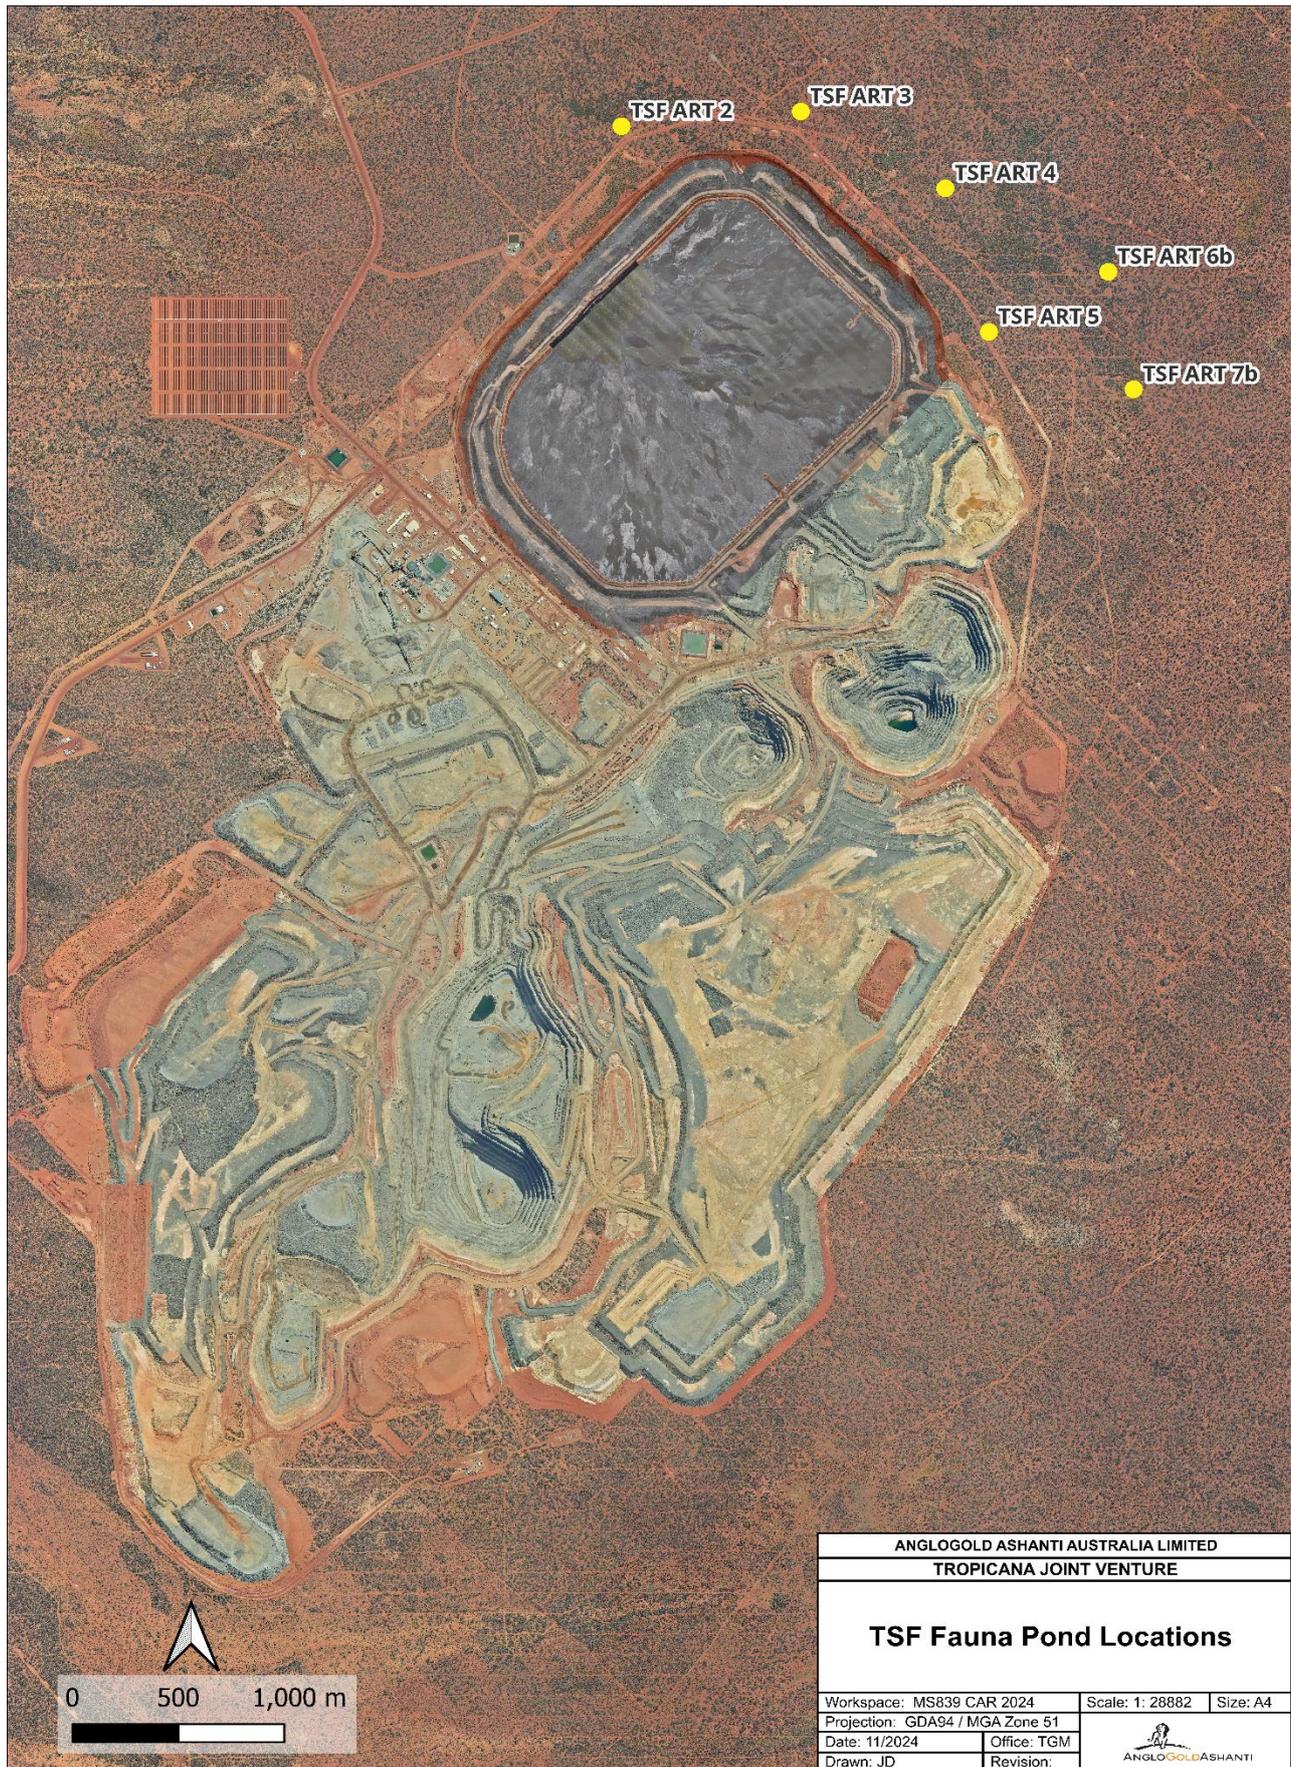
Figure 5: TSF Fauna Pond Locations

Several artificial water sources (Figure 5) have been established around the TSF to provide an alternate water source for wildlife which are monitored via motion-sensing cameras and periodically reviewed. Photographic monitoring has captured several fauna species utilising the artificial ponds including a variety of birds, marsupials, mammals and reptiles.

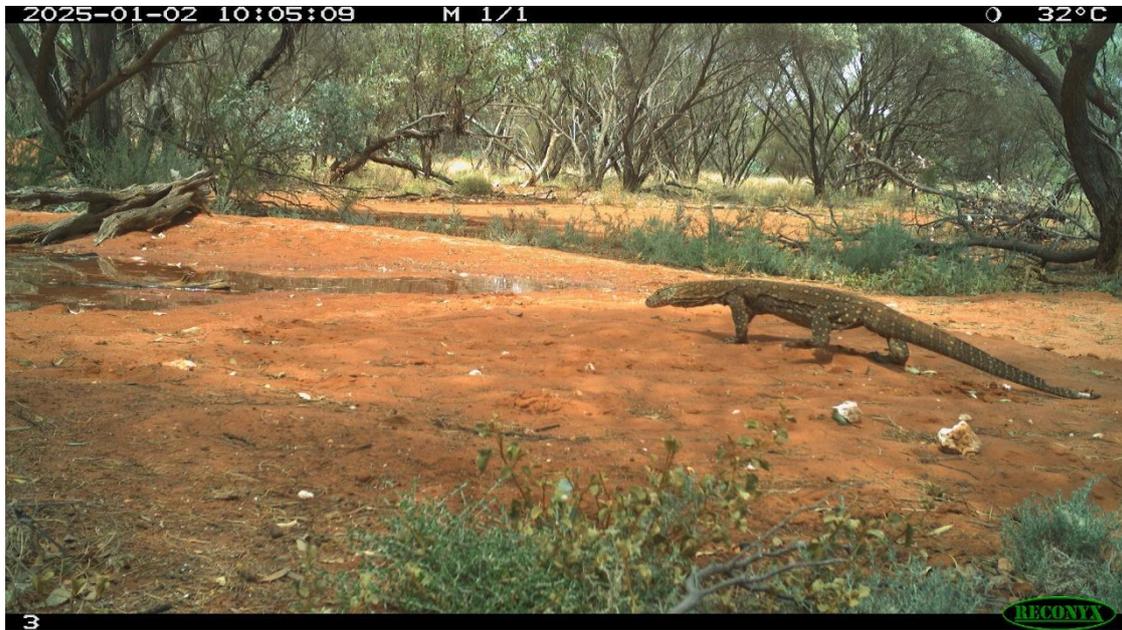
Plate 1: Photo monitoring of TSF artificial water sources [TSF ART 3] – Perente (January 2025)

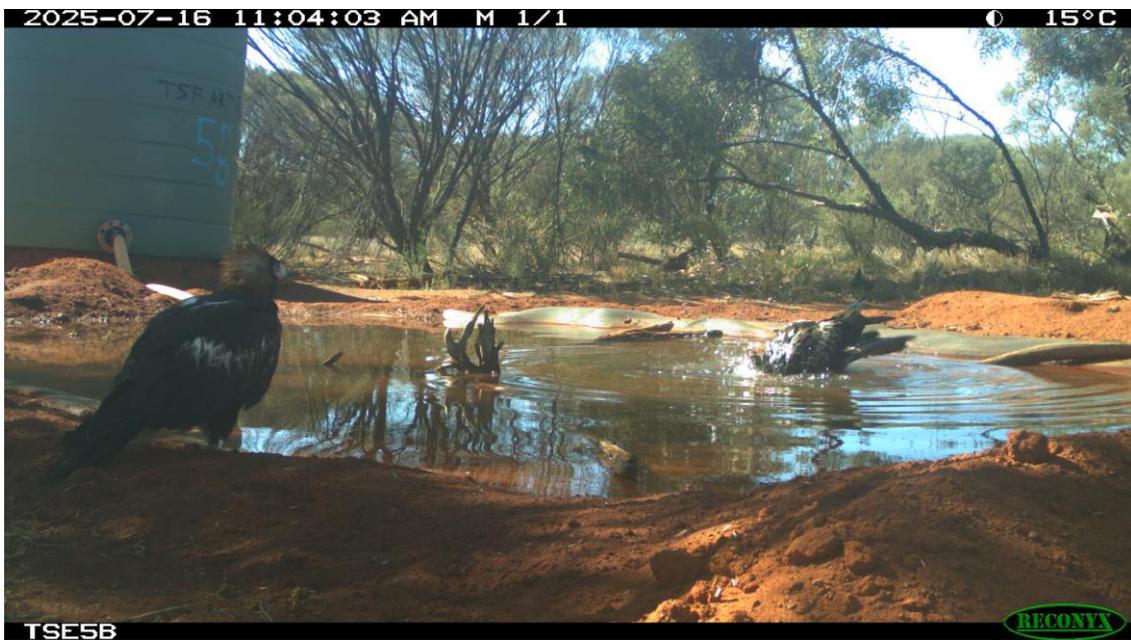
Plate 2: Photo monitoring of TSF artificial water sources [TSF ART 5B] – Pair of wedge-tailed eagles (July 2025)

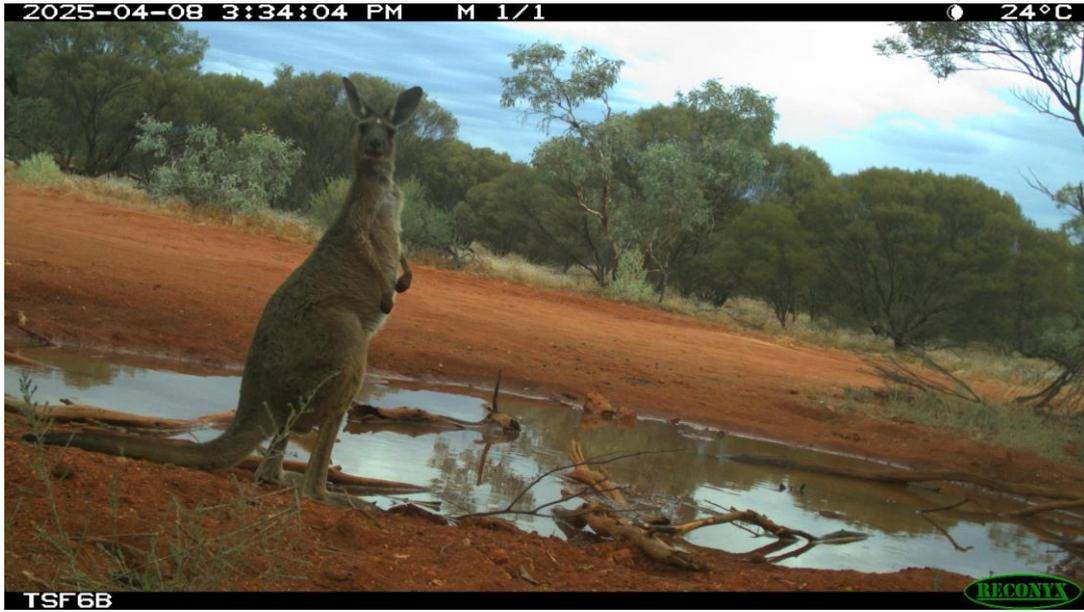
Plate 3: Photo monitoring of TSF artificial water sources [TSF ART 6B] – Kangaroo (April 2025)
