Tropicana Gold Project Ministerial Statement No. 839 – 2019/2020 Annual Compliance Assessment Report

Tropicana Gold Mine (TGM)
Ministerial Statement No 839
Annual Compliance Assessment Report
24 September 2019 to 23 September 2020

Document Reference: CAR20201222

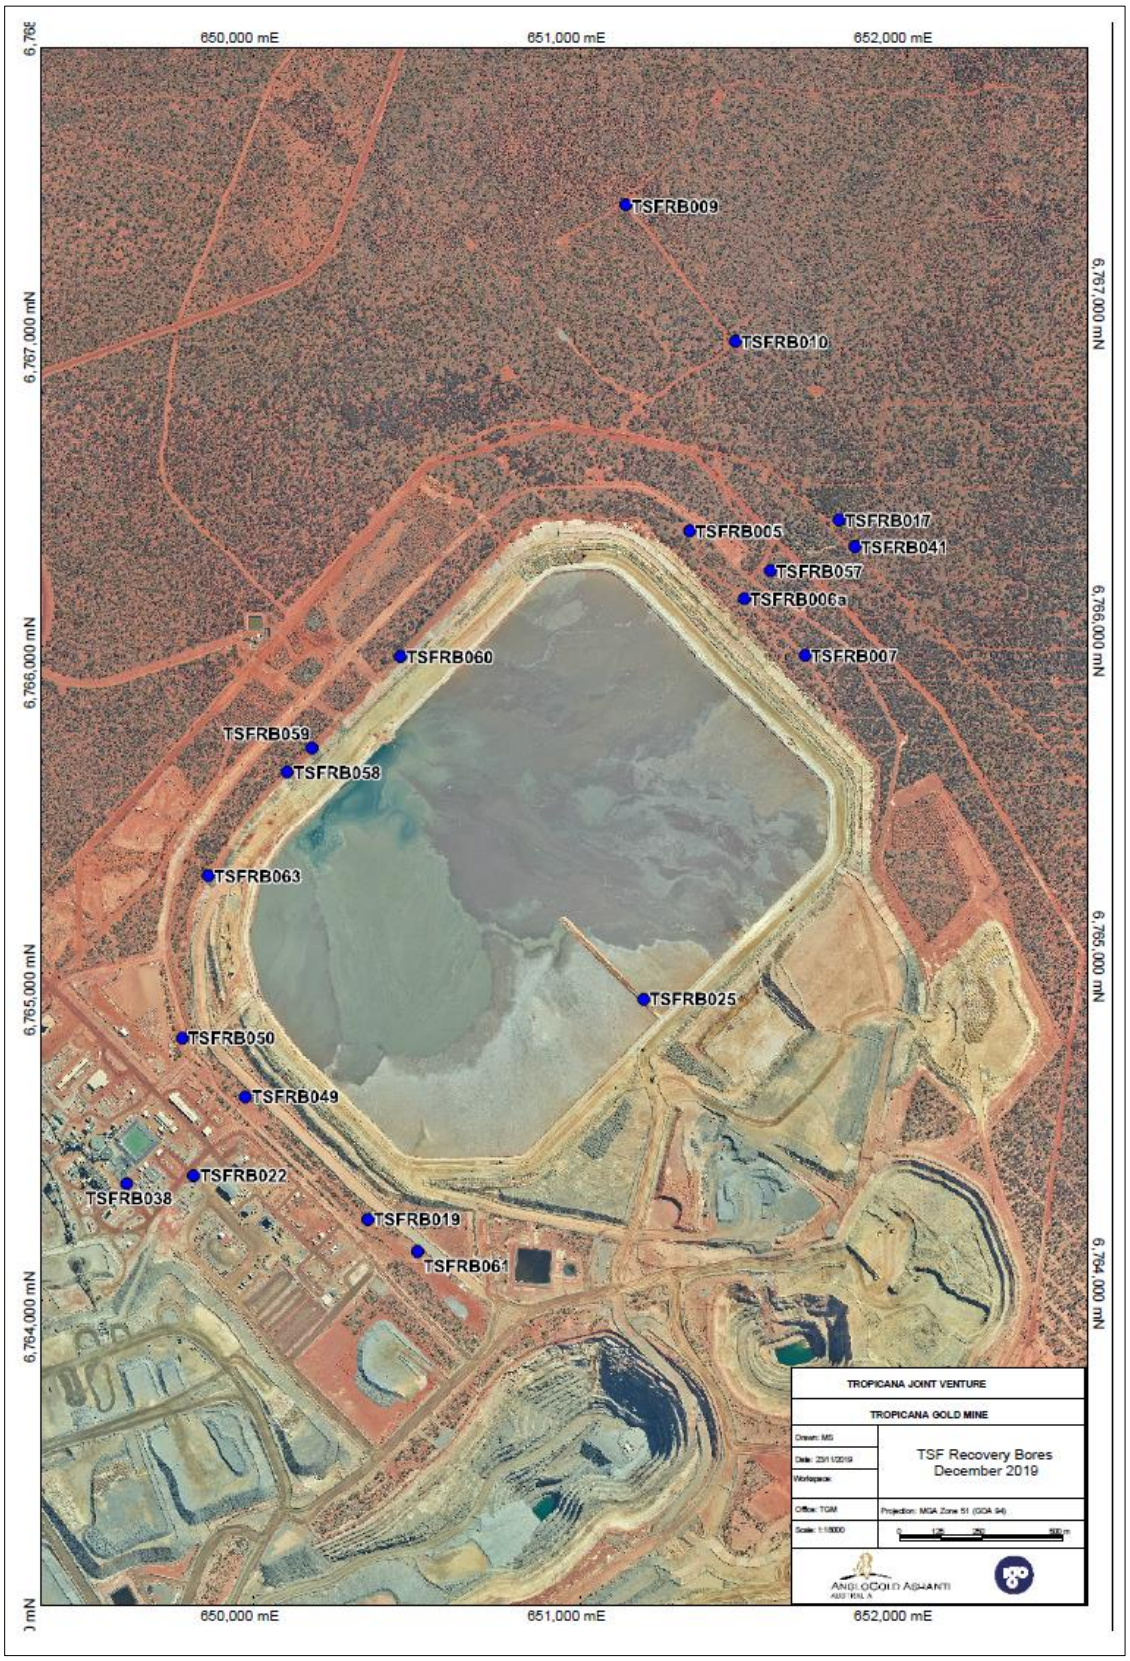
Figure 7: TSF Recovery Bores

The Seepage Mitigation Project was continued throughout the reporting period. Table 3 and Figure 7 provide an update on the status of the Seepage Mitigation Project.

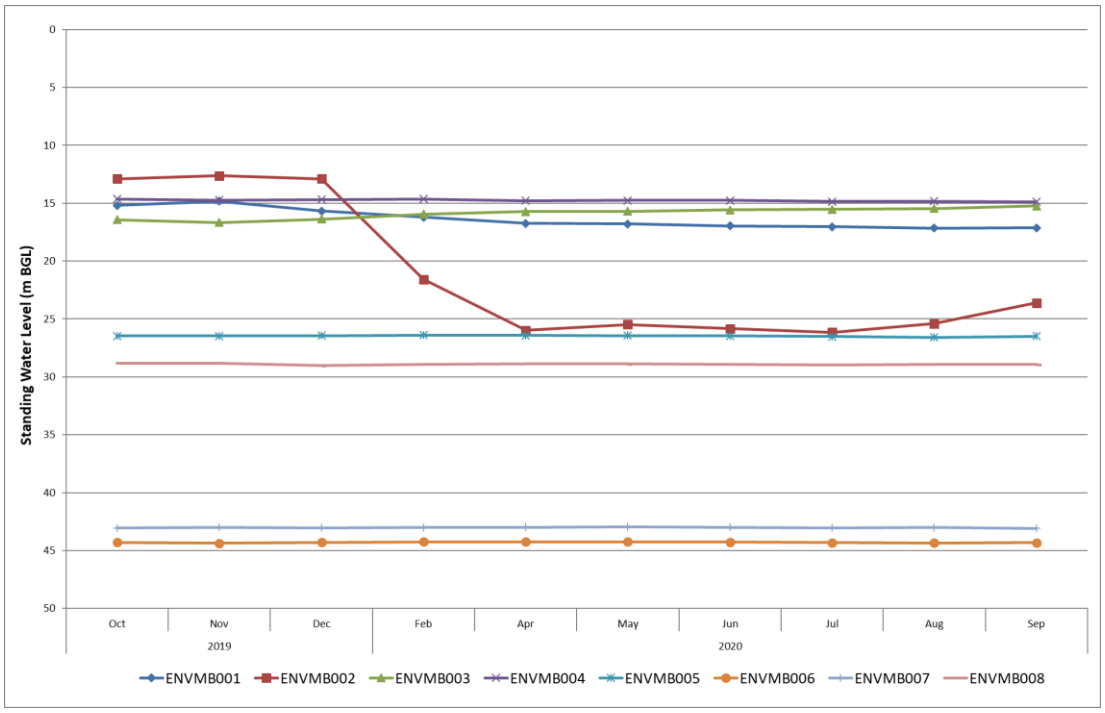
Figure 1 Groundwater Levels in Environmental Monitoring Bores 2019-2020 Reporting Period

- Monitoring bores ENVMB004-008 reported water level fluctuations of less than 0.5 m over the reporting period;
- ENVMB003 (west of the TSF) reported a 1.27 m rise in groundwater level;
- ENVMB002 fluctuated over the reporting period, with an overall decline of 9.74 m in response to abstraction bore pumping; and
- ENVMB001 reported a decline of 1.76 m in response to abstraction bore pumping during the reporting period.

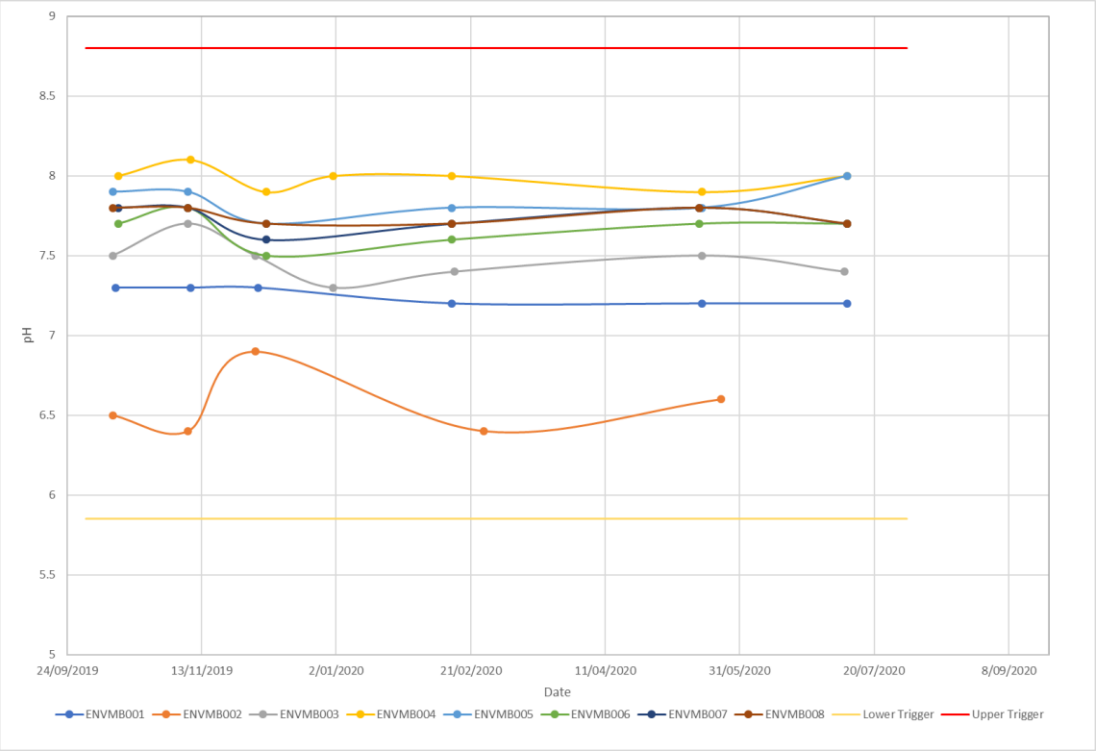
Figure 2 Laboratory pH in Environmental Monitoring Bores 2019-2020 Reporting Period

- pH in all bores was within trigger level thresholds during the reporting period.

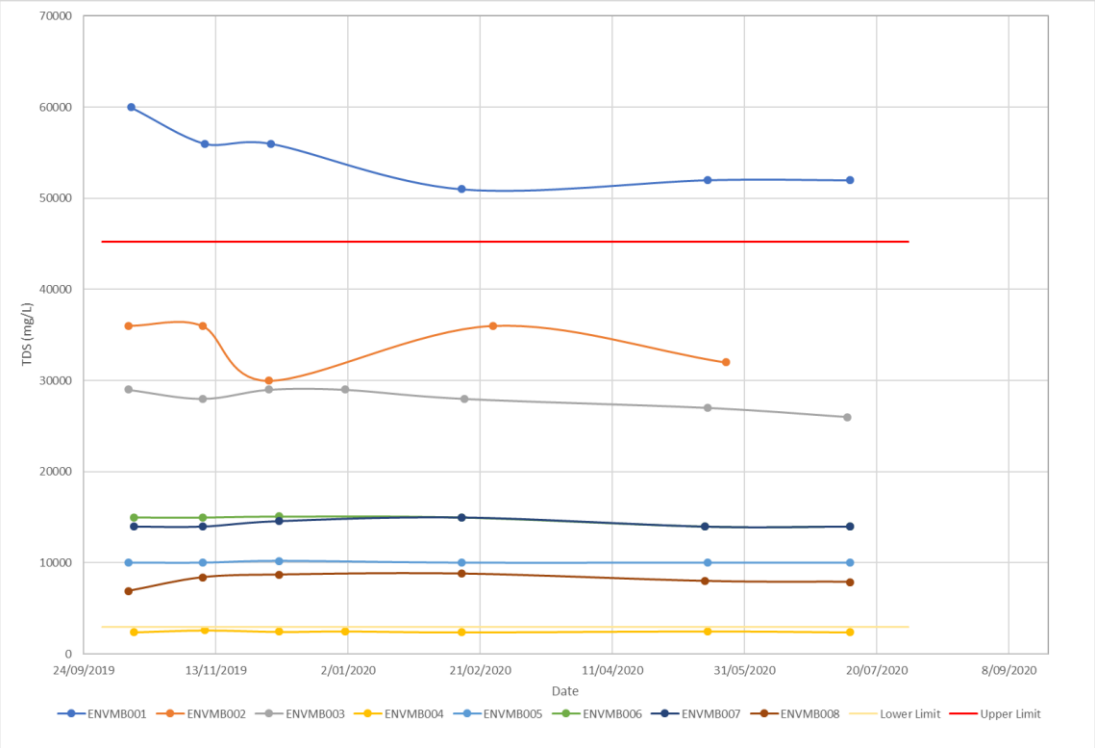
Figure 3 Total Dissolved Solids in Environmental Monitoring Bores 2019-2020 Reporting Period

- ENVMB004 was reported at, or slightly below, the lower trigger value and is in the brackish range. This represents the lower limit of salinity within the operational area, in the up-hydraulic gradient portion of the paleochannel system flowing broadly northward to the salt lake system north of the process water supply borefield;
- TDS in ENVMB001 remained hypersaline, and above the upper trigger value, as in previous periods, with a slight downward trend; and
- ENVMB002-003 and 005-008 were all within trigger value thresholds, ranging from saline to hypersaline and were consistent with previous years.

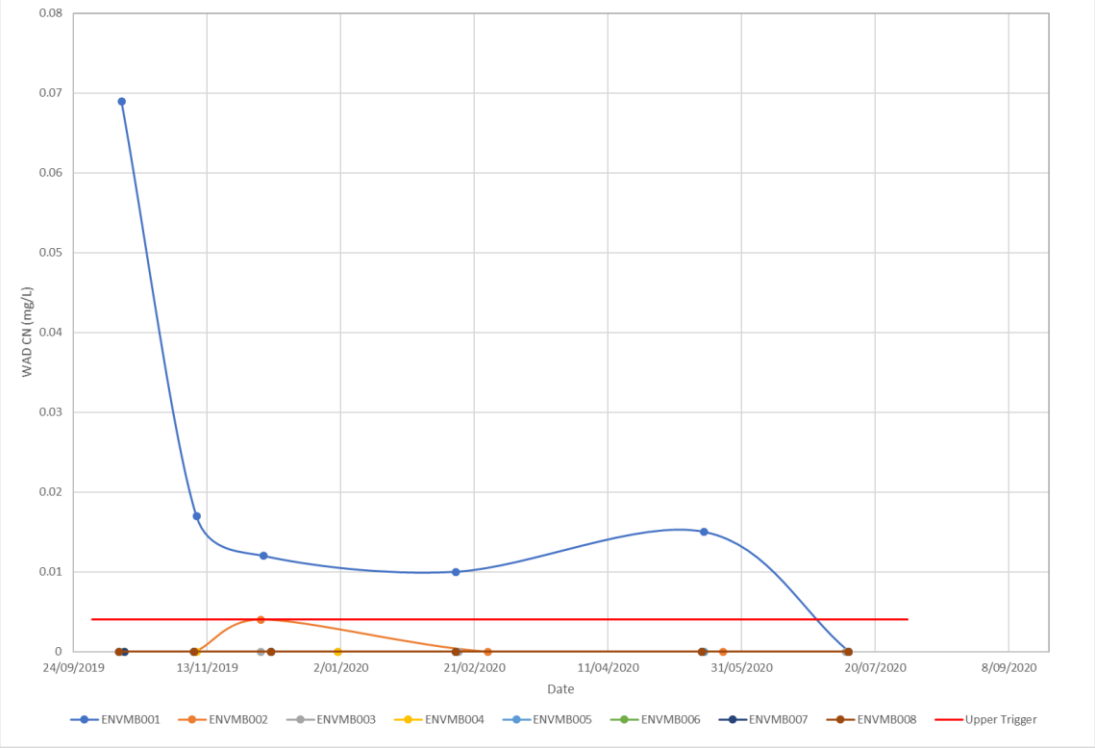
Figure 4 WAD Cyanide in Environmental Monitoring Bores 2019-2020 Reporting Period

- WAD cyanide was not reported above the laboratory limit of reporting (LOR) in bores ENVMB002-008;
- WAD CN was reported at concentrations between LOR and 0.069 mg/L at ENVMB001 during the reporting period, which is a comparable frequency to 2019 results. This monitoring bore is directly down-hydraulic gradient from the TSF and within the cone of depression of abstraction bores in this area.

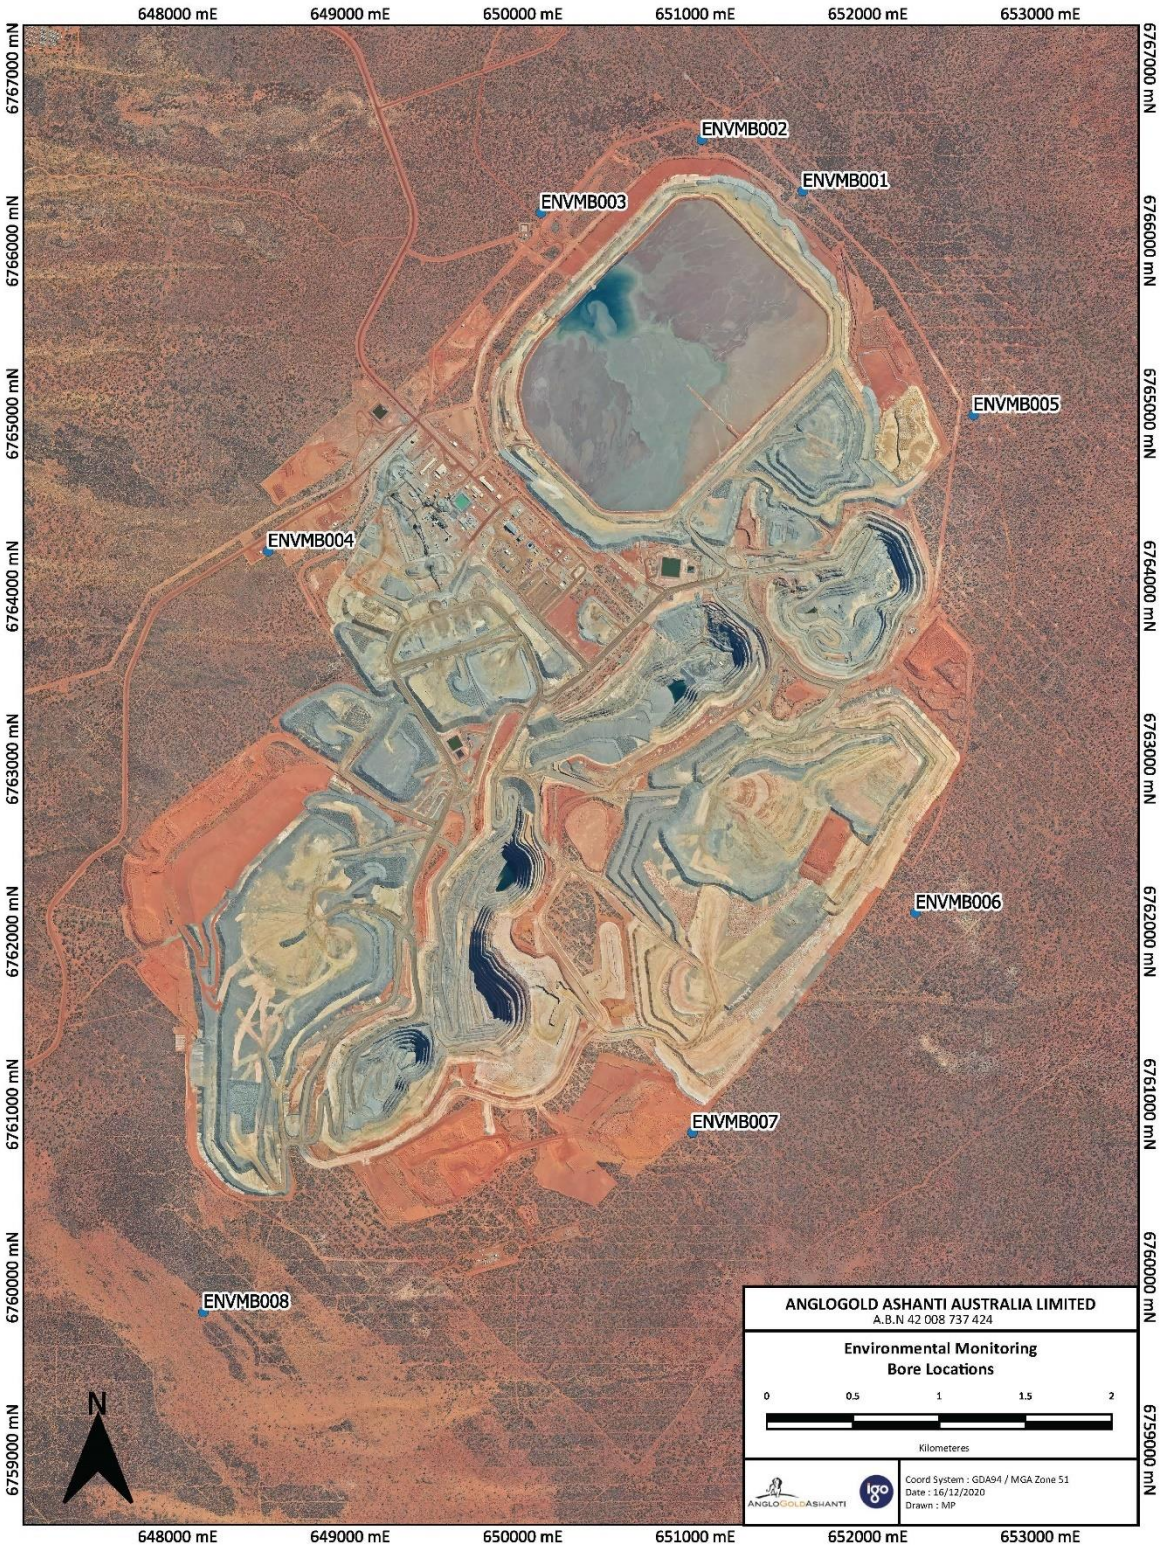
Figure 5 ENVMB001-008 Locations

The operation of the TSF has been observed to have had a localised impact to groundwater quality during the reporting period, in particularly at ENVMB001. Localised changes in groundwater quality are not considered to have had any detrimental impact to environmental values. The existing groundwater environment is typically saline to hypersaline and has no known beneficial users. Monitoring of vegetation condition in proximity to operational areas has not identified any impacts to vegetation health associated with changes in groundwater quality.

To mitigate potential impacts to environmental values, AGAA implemented a Seepage Mitigation Project in 2016 – refer to Section 4.2 of the CAR for additional information. AGAA will continue to monitor groundwater across the TGM and will implement additional mitigation actions as and when required to minimise the environmental impacts of the operation.

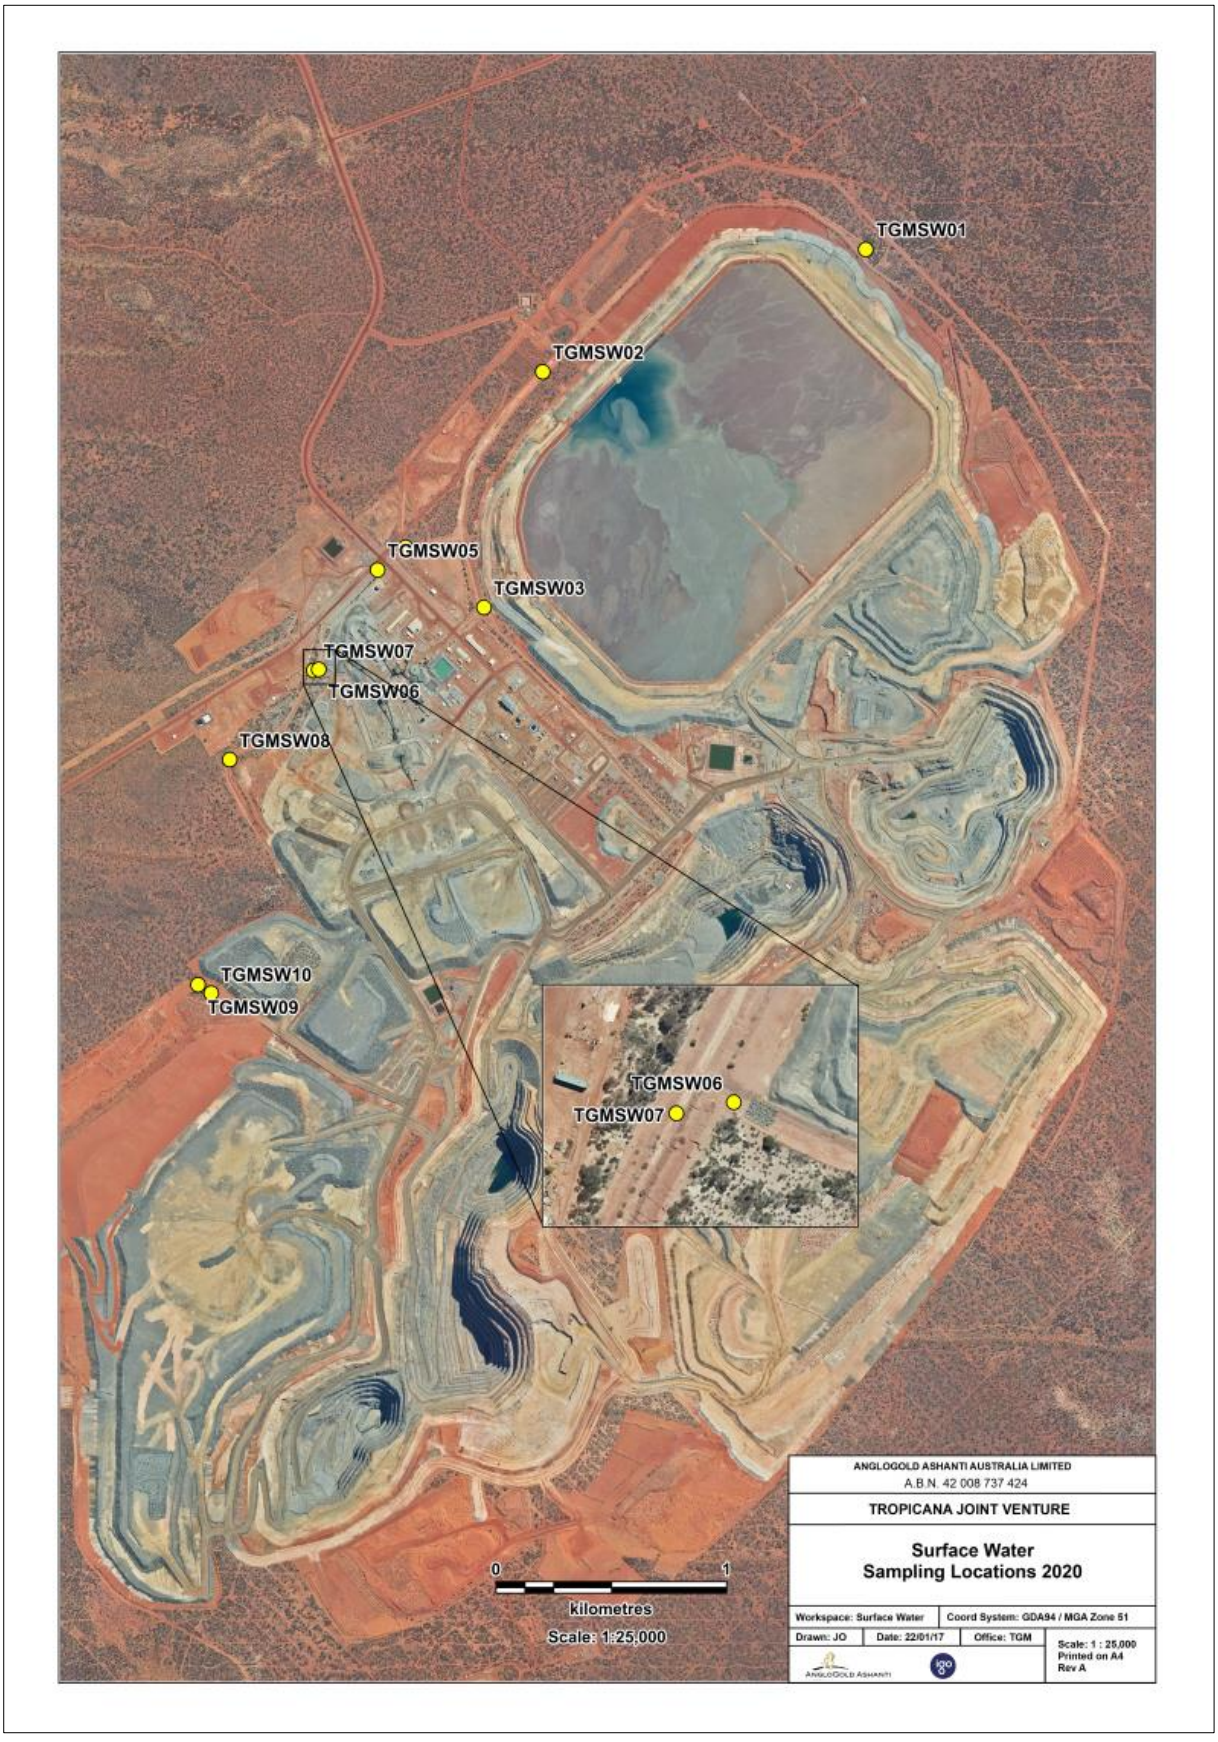
Figure 1 Stormwater Sampling Locations

The following locations were sampled (Figure 1). Monitoring points 06 and 09 did not contain standing water and were not sampled.
